## CeramAlloy Used for Critical Pump Repairs At Nuclear Station... Saves \$90,000 in Replacement Costs!

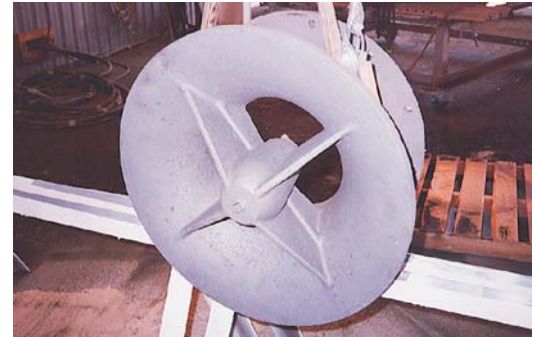
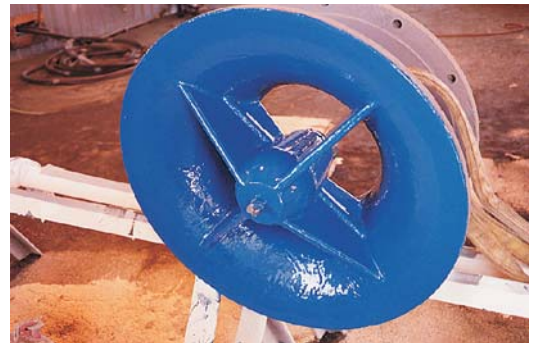
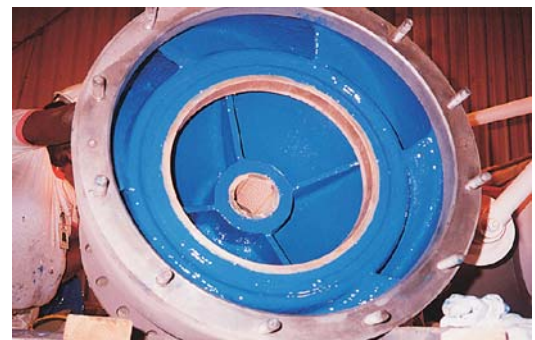
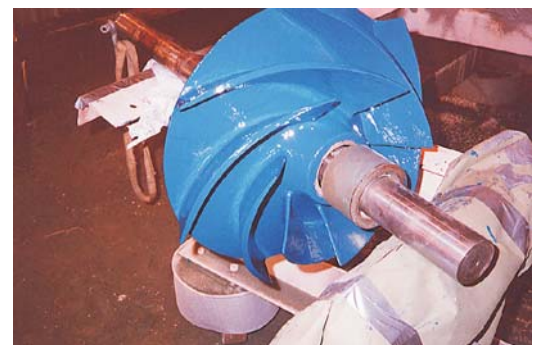
The plant engineers at a nuclear power station located in the Pacific Northwest in the US discovered severe erosion/corrosion wear on the impeller, the suction bell and the diffuser bowl of a large submersible pump. This tower make-up water pump supplies water from the river to the cooling towers.

Sand and silt entrained in the river water accelerated the erosion damage to the pump while electrolysis problems had also accelerated the corrosion damage.

All the pump components were first abrasive blasted to a 3-4 mil profile. All pitted areas on the diffuser bowl and the suction bell were then filled using CeramAlloy CP+ followed by the application of two coats of CeramAlloy CL+. The impeller, due to the rough surface, was coated with brush-applied CP+ to fill in as a base for the subsequent two coats of CL+.
