\$300,000 Repair Project Completed at Major Northeastern Utility. 40-Year Old Cast Iron Water Boxes & Tube Sheets Repaired & Protected With CeramAlloy.

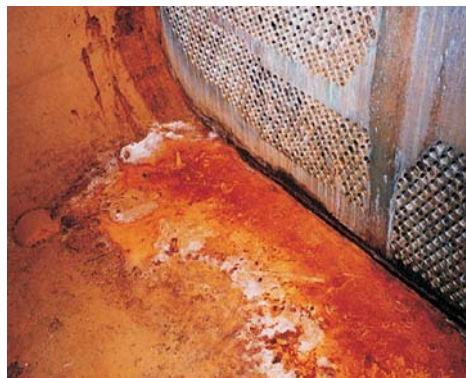
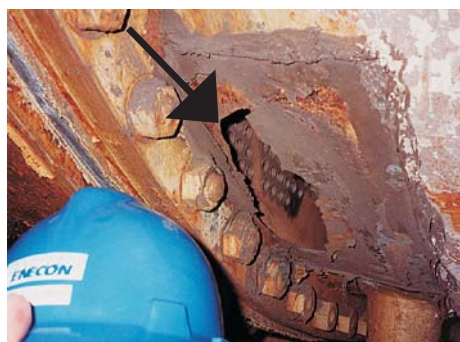
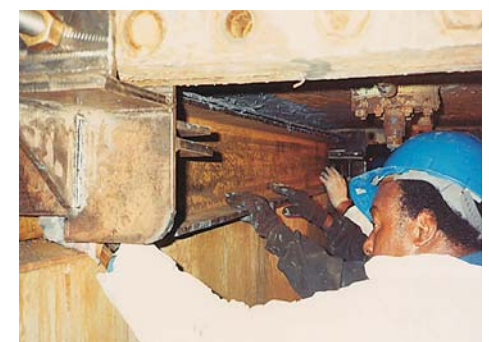
A total of 8 cast iron water boxes which were built in the 1950's plus 8 tube sheets were repaired, rebuilt and resurfaced with **ENECON CeramAlloy**

The cast iron water boxes were so severely damaged that huge holes, exposed during grit blasting, had to be repaired using steel plates and girders bonded and sealed with CeramAlloy.
