Nuclear Power Station Finds ENECON The Best Solution For Critical Shaft Repairs

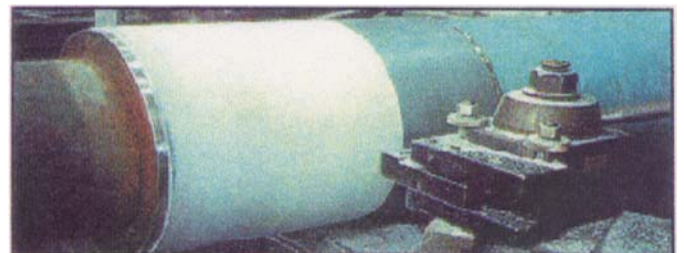
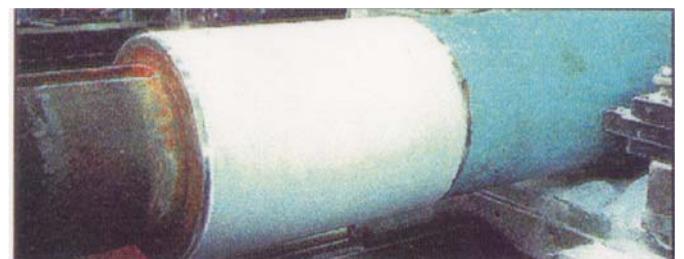
By using heat lamps to accelerate the cure, the DurAlloy could be machined after about one hour. The excess material was machined away - with the final pass of the cutting tool removing only a few thousandths of material, followed by polishing with an emery cloth to yield the desired finish.
