## Texas Hospital Complex Solves its Air Conditioning Problems With ENECON CeramAlloy

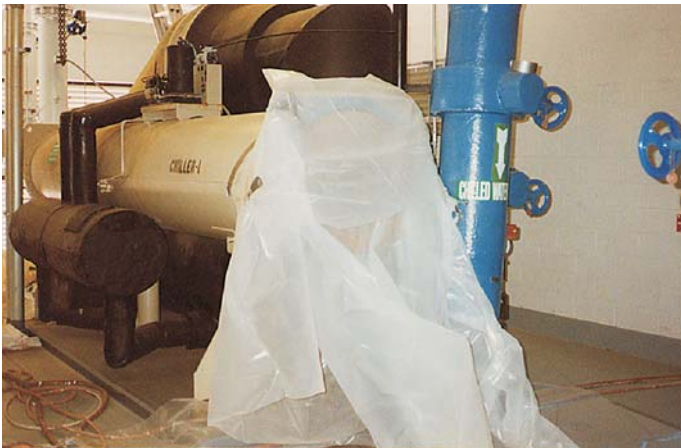
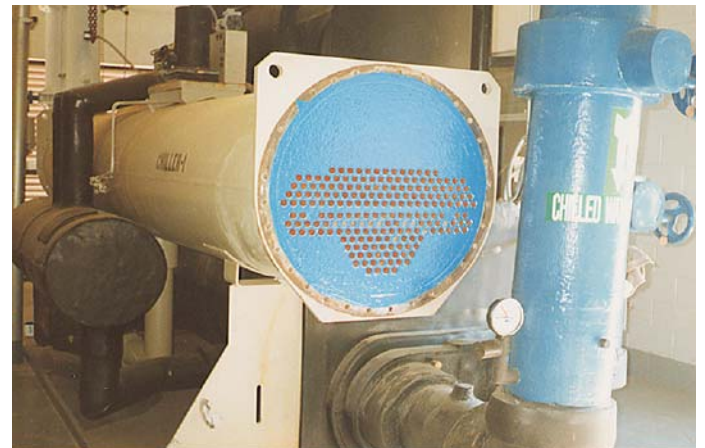
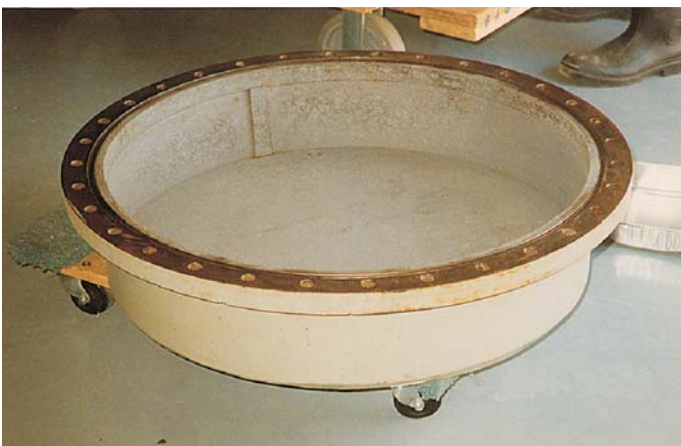
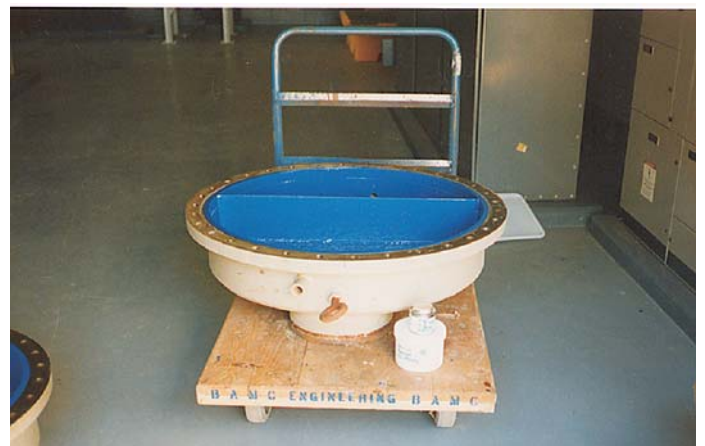
Erosion and Corrosion damage was evident on the chillers of their

air conditioning system and they wanted the best material to repair the damage and provide long-term protection from future damage.

The ENECON engineer suggested the cost

effective solution...CeramAlloy CP+ and CL+ to rebuild any damaged metal and then resurface the end covers as well as the tube sheets on the chiller.
