Plug Mill at Pottery Plant Handling Highly Abrasive Clay, Repaired & Protected With CeramAlloy

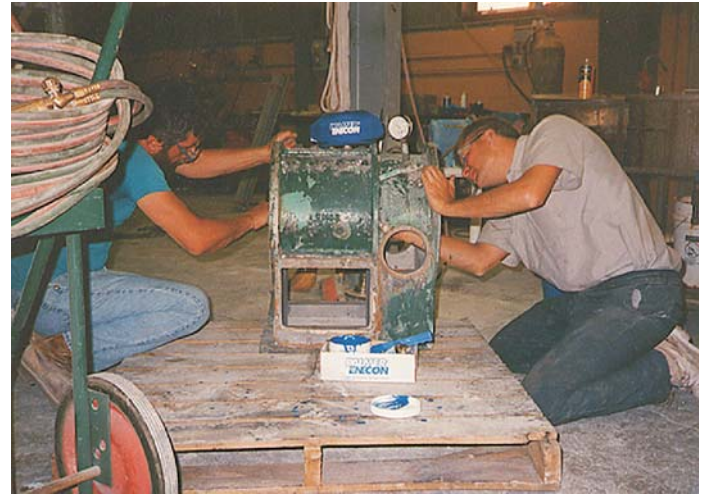
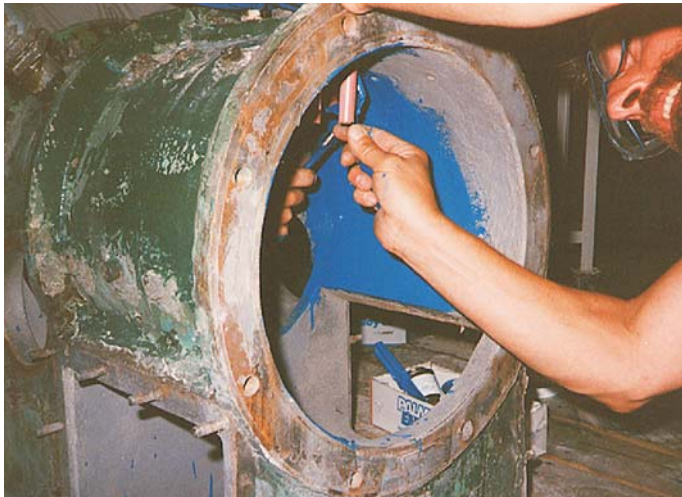
Highly abrasive clay wore the nickel plating inside this plug mill -- a type of

pump designed to remove air from clay. The clay is then extruded as a solid cylindrical plug.

Nickel contamination in the clay caused defective pottery when fired. The plug mill had to be shut down until the problem could be solved.

The local ENECON Fluid Flow Systems Specialist was called in for his expert advice and he immediately recommended ENECON CeramAlloy CL+ to resurface the damaged wear surfaces of the plug mill.

The application was

completed by the plant's own maintenance engineers and took just one day to complete.

Just \$600 worth of CeramAlloy was needed to repair the plug mill good as new -- maybe better!
