## METALCLAD DurAlloy Raises Hydraulic Anchor Winch from Depths of Despair

The shaft of this vessel's hydraulic anchor winch was found badly in need of repair during a routine maintenance inspection in Israel.

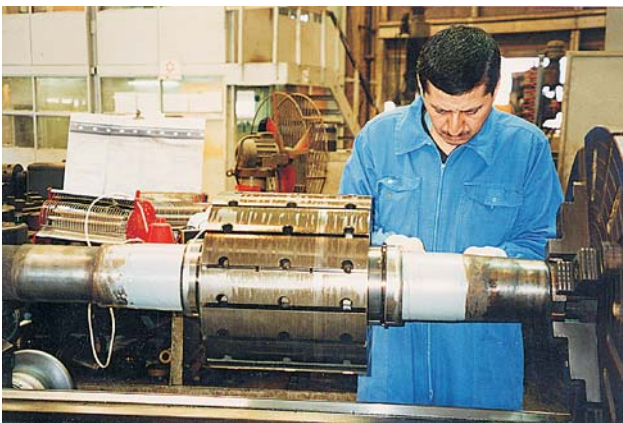
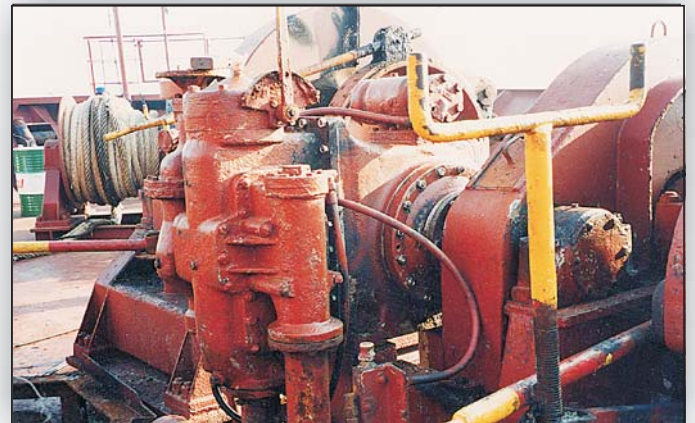
Since **damage had not been anticipated**, it was imperative that repairs be completed as quickly as possible. In addition, the risk of possible heat distortion to the shaft could not be tolerated.

DurAlloy and well established repair techniques proved an unbeatable combination.

The shaft was rebuilt and machined to the exact dimensions required in a matter of only a few hours without any worry about heat distortion; and the anchor winch was re-assembled and **back in service the next day**.
