## CeramAlloy Saves Down-Time & Aggravation for Power Plant Engineers

During the first weekend of a scheduled outage, this coal fired power plant in the southeastern United States discovered some extensive but unexpected damage to a number of heat exchanger components.

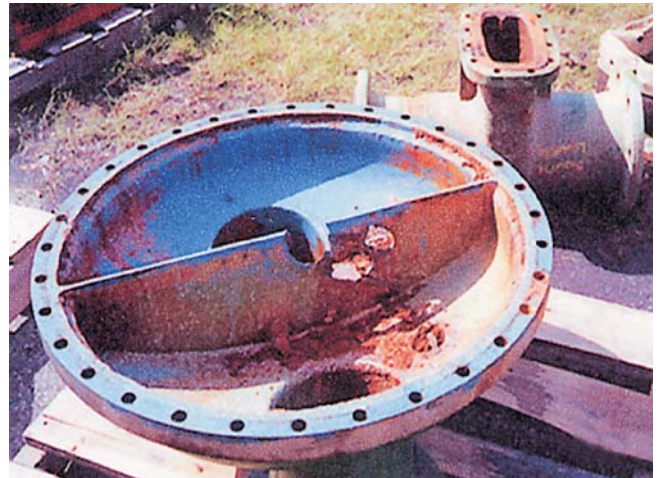
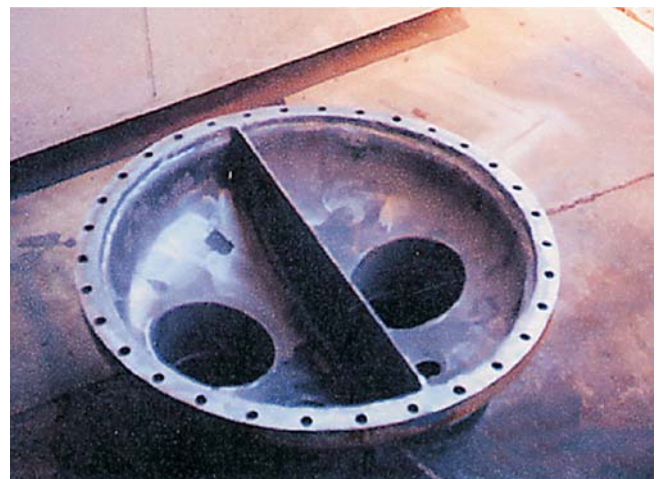
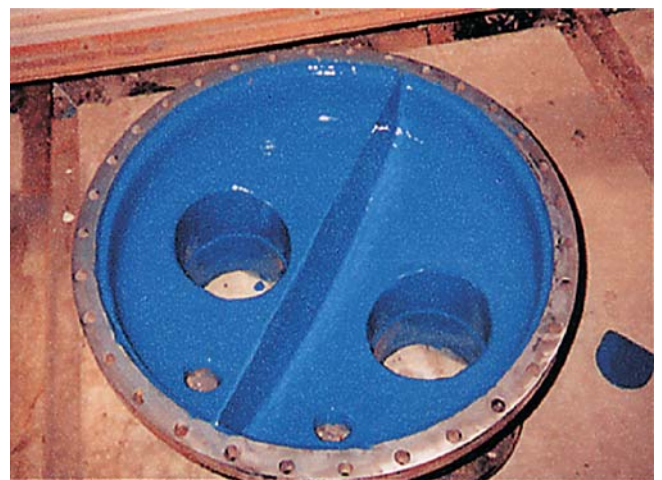
The rebuilding of the holed areas involved the use of metal screening and CeramAlloy CP+[AC] to bridge the gaps and build up the required thickness. After grinding the CP+[AC] to complete the system and protect the equipment from further erosion and corrosion.

The repaired components were returned to the plant on Friday and installed over the weekend - enabling the plant to be back in operation on Monday morning as originally planned.
