CeramAlloy Saves Down-Time & Aggravation for Power Plant Engineers

During the first weekend of a scheduled outage, this coal fired power plant in the southeastern United States discovered some extensive but unexpected damage to a number of heat exchanger components.

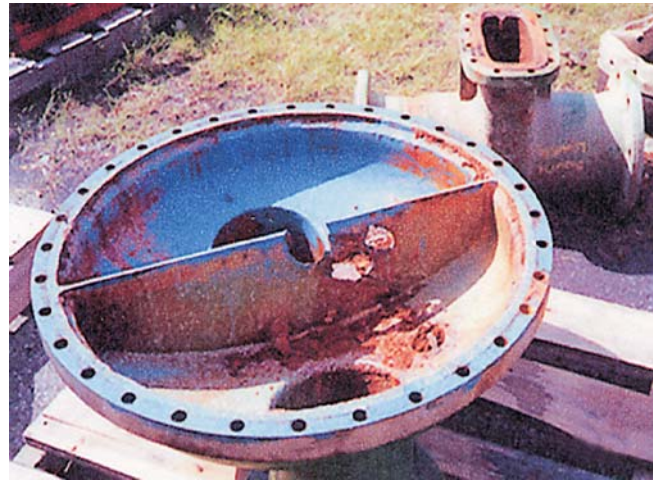
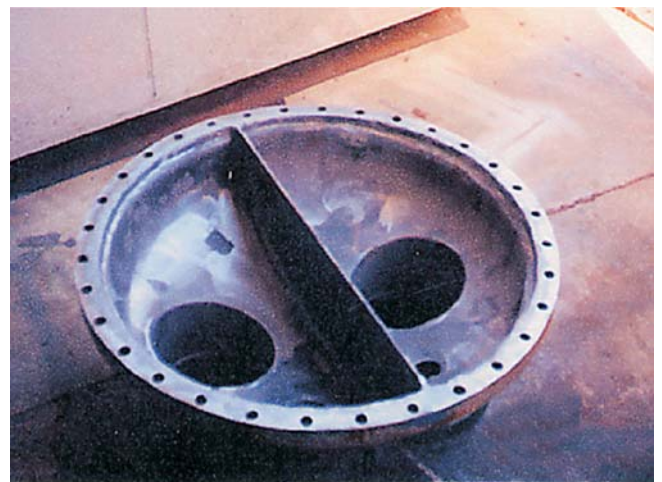
The rebuilding of the holed areas involved the use of metal screening and CeramAlloy CP+[AC] to bridge the gaps and build up the required thickness. After grinding the CP+[AC] to complete the system and protect the equipment from further erosion and corrosion.

The repaired components were returned to the plant on Friday and installed over the weekend - enabling the plant to be back in operation on Monday morning as originally planned.
