## U.S. Aircraft Carrier Seals Leaking Hatches on Flight Deck

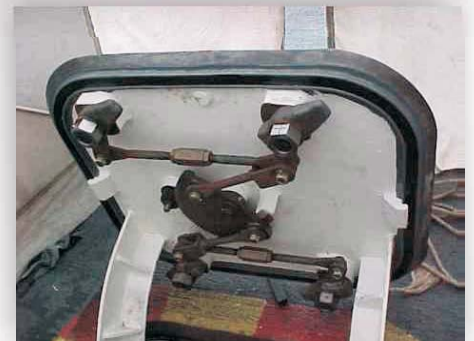
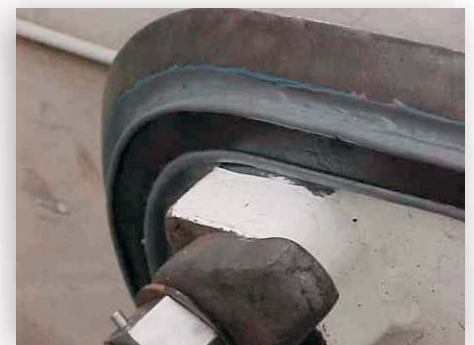
What often happens, however, is the gasket retainer corrodes due to constant immersion in saltwater, fuel, hydraulic fluid, etc. As a result, the hatches leak and the AESS lockers can fill with water. This is not a good thing.

more “high-tech” approach. The damaged areas were repaired with DurAlloy then sanded smooth to the desired shape and dimension. Two coats of CeramAlloy CL+ [AC] were then applied over the entire seal area to provide long-term corrosion protection to these hatches.
