Largest US Gold Producer Repairs Heat Exchanger With CeramAlloy

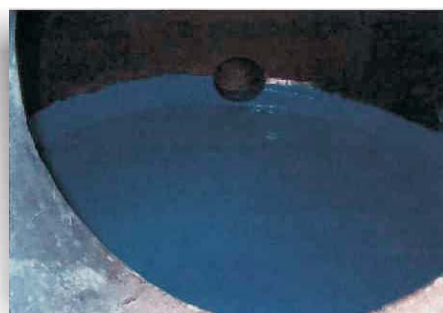
Water box repaired & coated

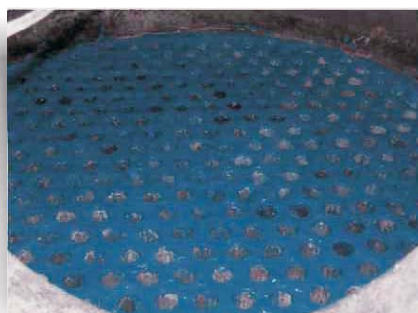
Tube sheet repaired & protected
