International Metals Manufacturer in Australia Solves Severe Wear & Abrasion Problems with CeramAlloy CBX

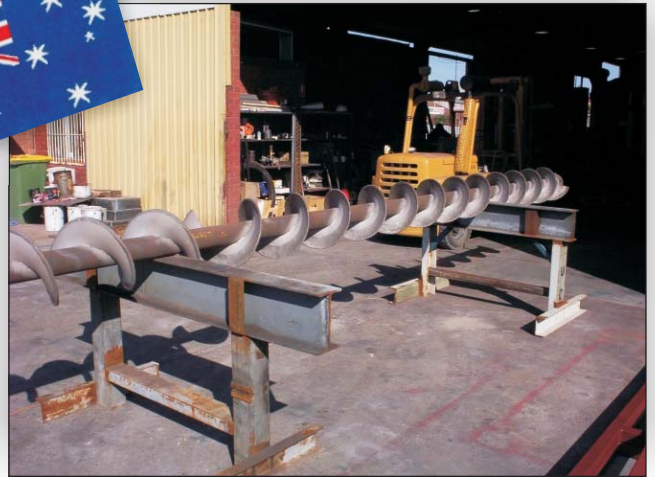
Conveyor after grit blasting

The ENECON Australia Engineering Team recommended **CeramAlloy CBX** to provide long-term protection to this critical piece of equipment. The screw conveyor was grit-blasted and then coated with 5 mm of CBX.

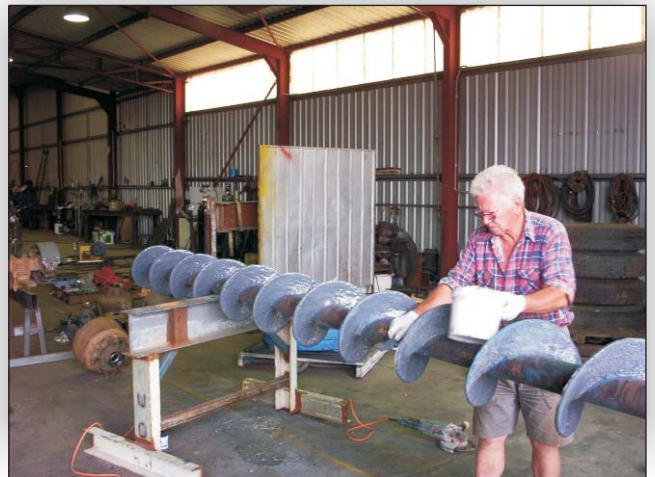
CeramAlloy CBX being applied

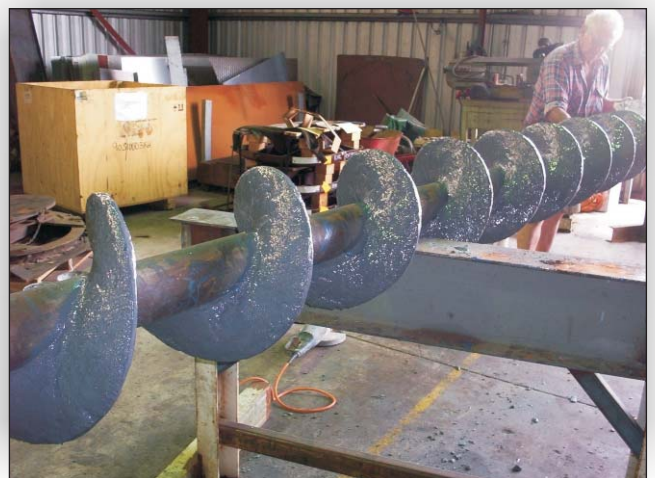
Screw conveyor protected with CBX

At a large metal manufacturing plant located in Western Australia, the maintenance engineers were experiencing accelerated damage to this screw conveyor from the abrasive Aluminum Hydrate that is being transported. They needed a high performance, wear resistant material that they could use to protect their conveyor.
