## CeramAlloy Repairs and Protects Wicket Gates at Spanish Hydroelectric Power Station

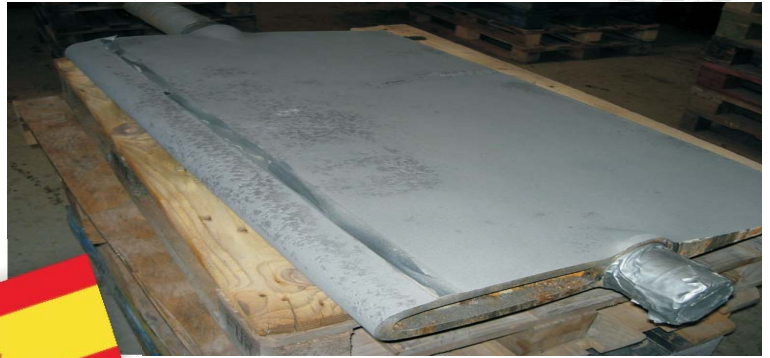
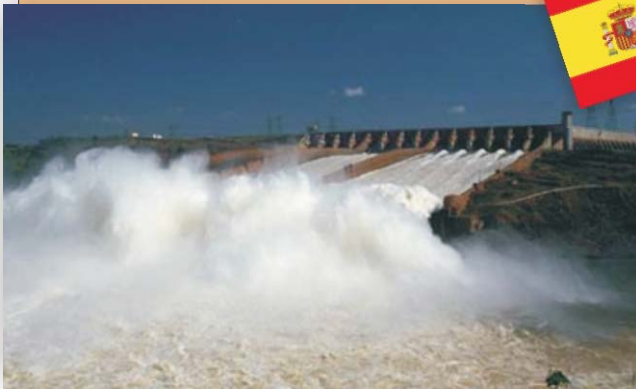
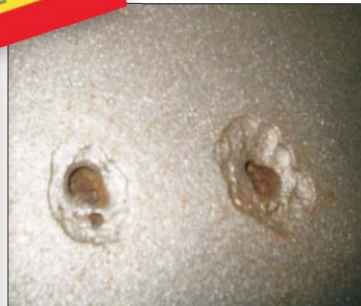
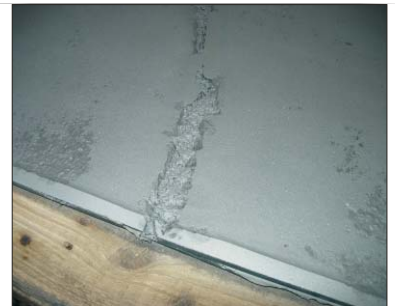
One of Spain's largest hydroelectric power stations was experiencing erosion and corrosion on its turbine wicket gates.

The station's engineers attempted to solve this problem by welding, but to no avail. Erosion damage was returning and deeper than before.

Upon review of the situation, it was recommended that the erosion damage (pitting) on the wicket gates be rebuilt with CeramAlloy CP+AC, followed by two coats of CeramAlloy CL+AC.

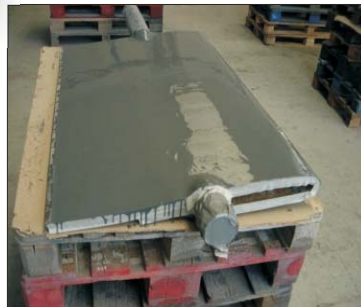
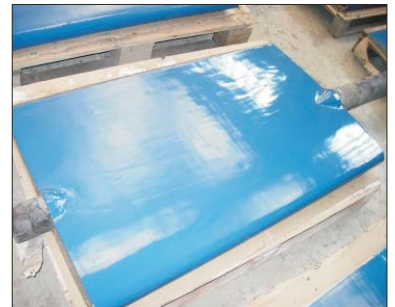
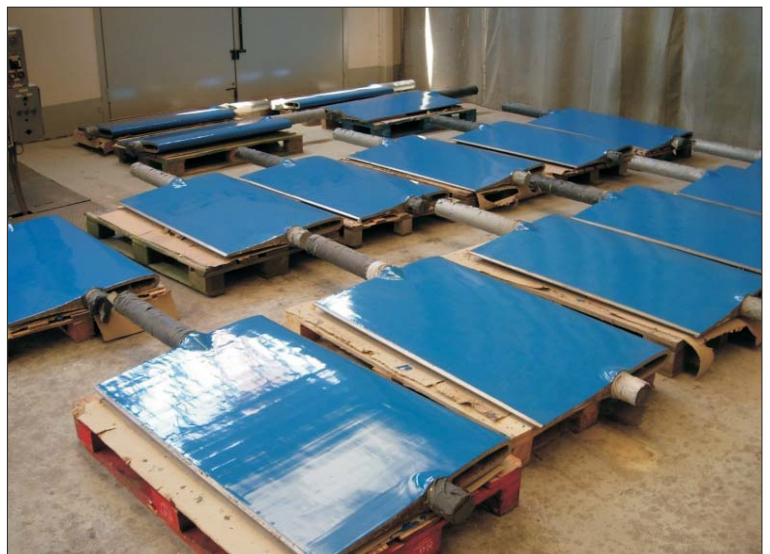
After the turbine wicket gates were repaired and resurfaced, the result was a smooth surface that is more erosion and corrosion resistant than the original metal.
