CeramAlloy Repairs and Protects Wicket Gates at Spanish Hydroelectric Power Station

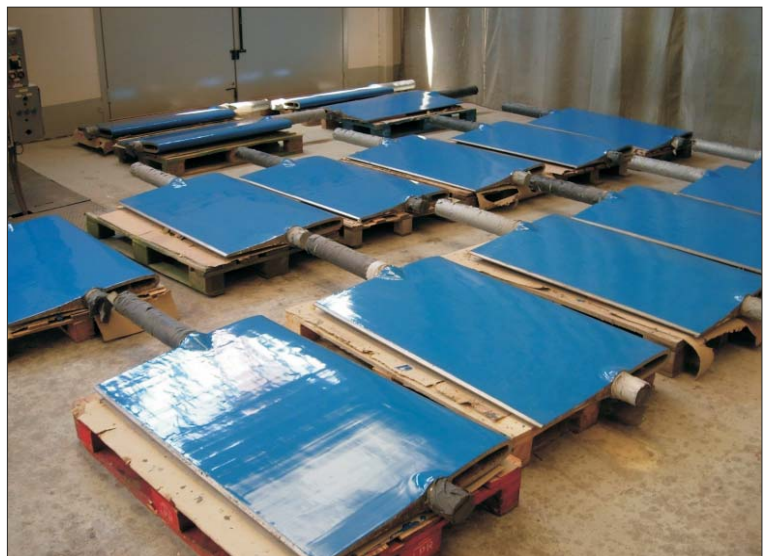
After the turbine wicket gates were repaired and resurfaced, the result was a smooth surface that is more erosion and corrosion resistant than the original metal.
