## Francis Turbine at Spanish Hydroelectric Plant Repaired and Protected with CeramAlloy

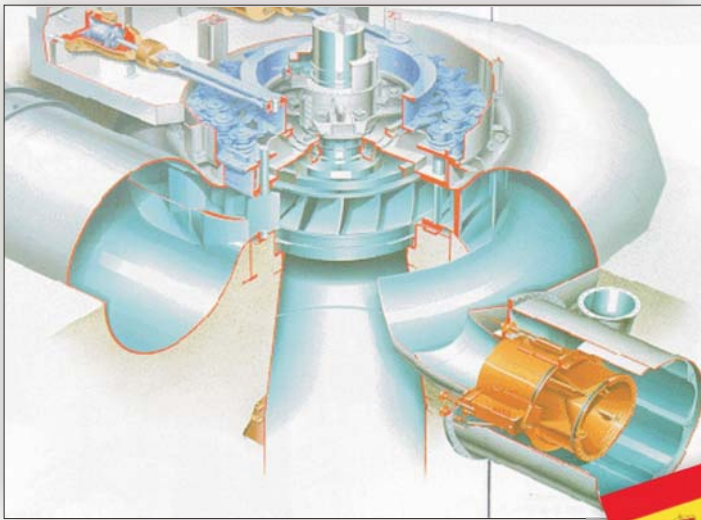
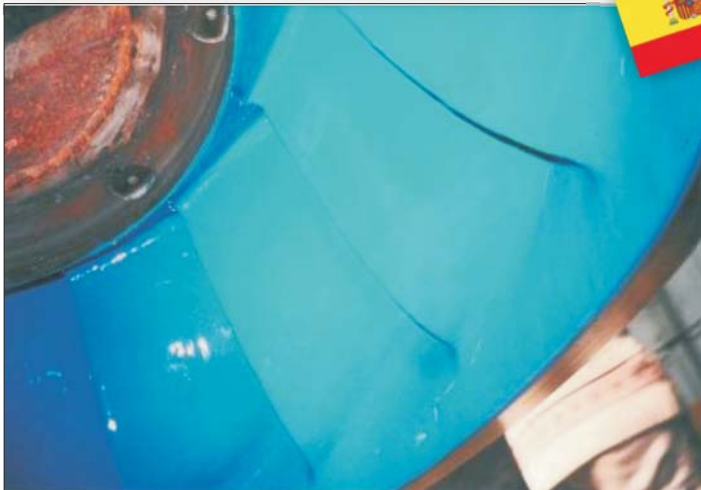
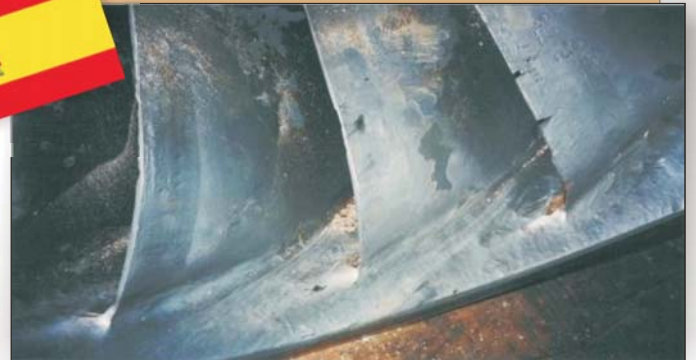
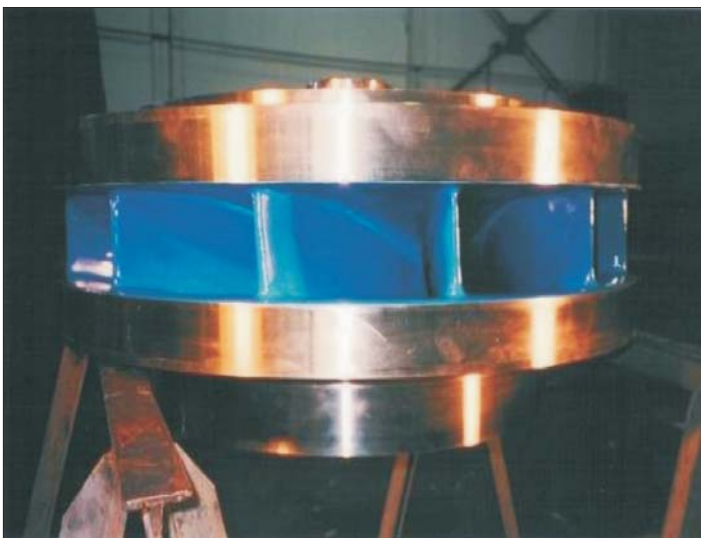
This Francis turbine at a Spanish Hydroelectric plant was only in operation for 3 years before it started showing erosion damage caused by sand in the water. This erosion was causing the turbine blades to become very thin which reportedly resulted in loss of power.

He recommended that METALCLAD CeramAlloy CP+AC be used to rebuild

the turbine blades. Two coats of METALCLAD CeramAlloy CL+AC were then used to help protect the turbine blades from future erosion damage.

This turbine rotates at approximately 1,000 rpm. Now after 5 years the plant engineers have reported no further erosion or loss of power on this turbine.
