Francis Turbine at Spanish Hydroelectric Plant Repaired and Protected with CeramAlloy

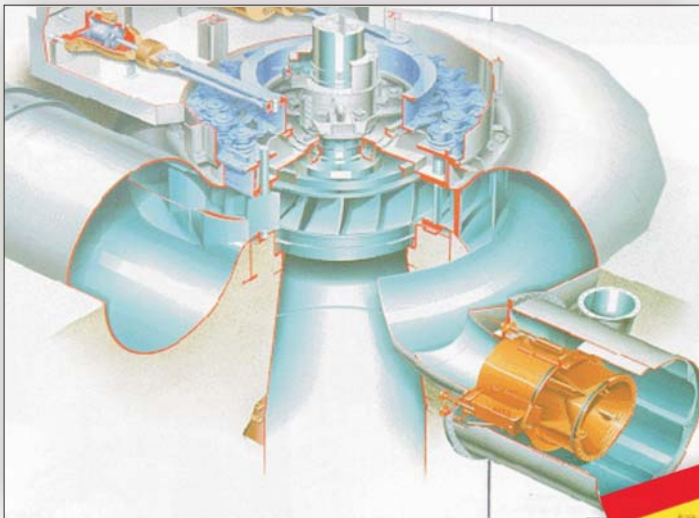
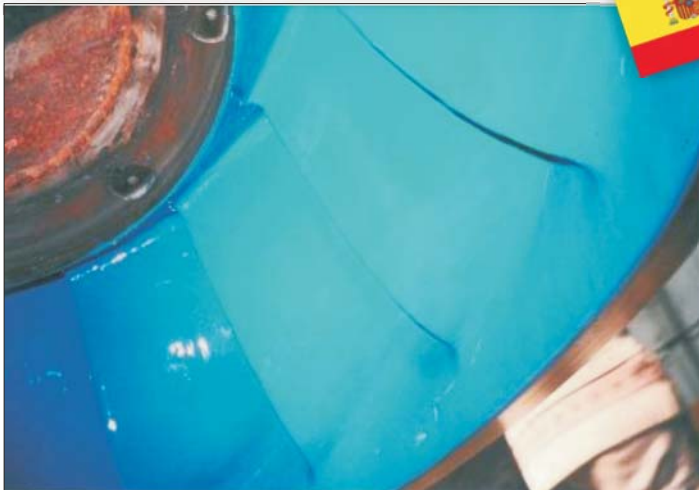
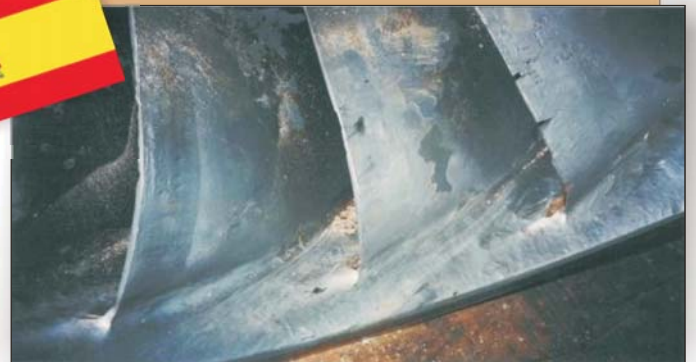
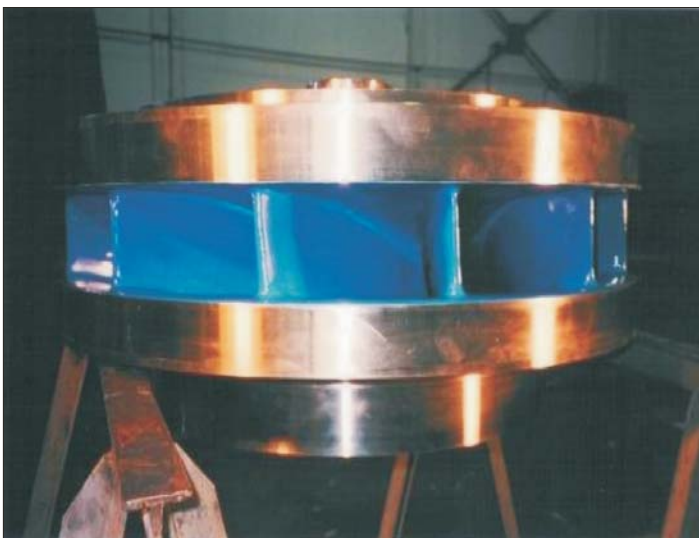
This Francis turbine at a Spanish Hydroelectric plant was only in operation for 3 years before it started showing erosion damage caused by sand in the water. This erosion was causing the turbine blades to become very thin which reportedly resulted in loss of power.

He recommended that METALCLAD CeramAlloy CP+AC be used to rebuild

the turbine blades. Two coats of METALCALD CeramAlloy CL+AC were then used to help protect the turbine blades from future erosion damage.

This turbine rotates at approximately 1,000 rpm. Now after 5 years the plant engineers have reported no further erosion or loss of power on this turbine.
