Spanish Nuclear Plant Uses CeramAlloy to Repair & Protect Cooling Tower Pumps

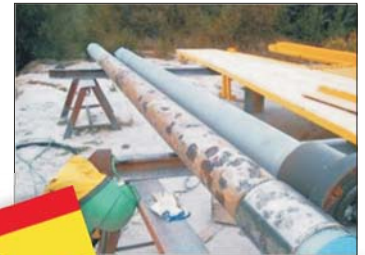
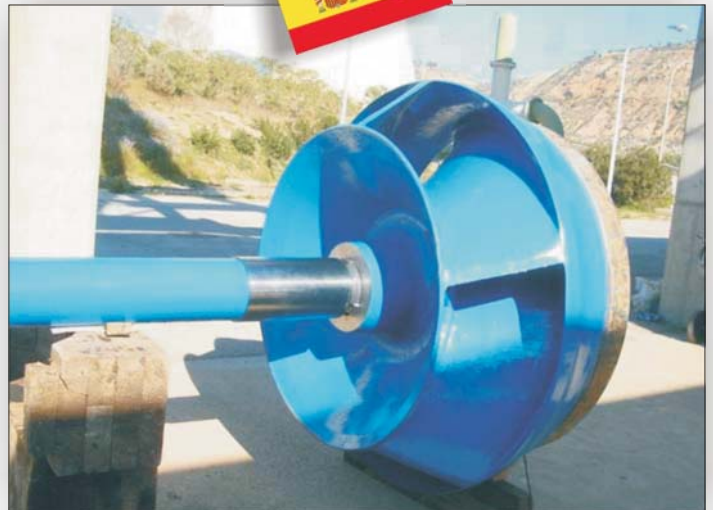
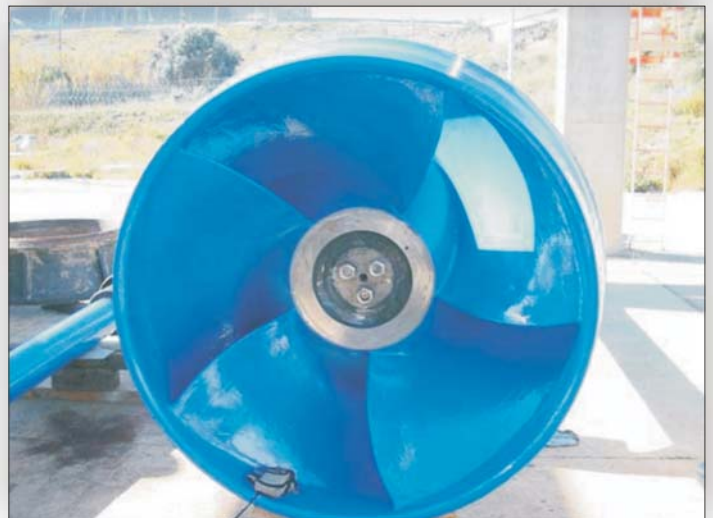
An important Nuclear plant in Spain had been experiencing erosion and corrosion on four pumps that supplied water to their cooling towers.

To repair the pumps the surfaces were grit blasted.

CeramAlloy CP+ was first applied to repair any damaged areas. That was then followed by an application of CeramAlloy CL+ for protection against further erosion and corrosion.
