Air Extraction Fan Blades From Australian Mining Operation Re-Built & Protected With CeramAlloy

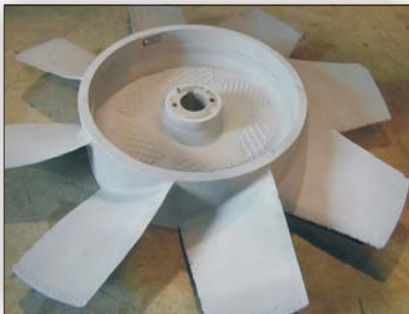
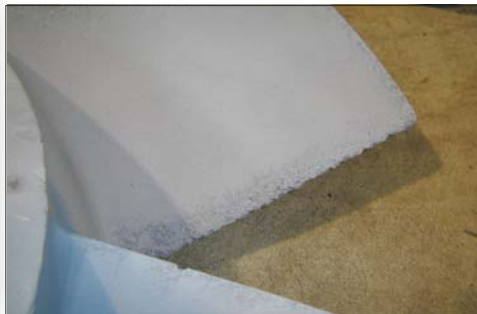
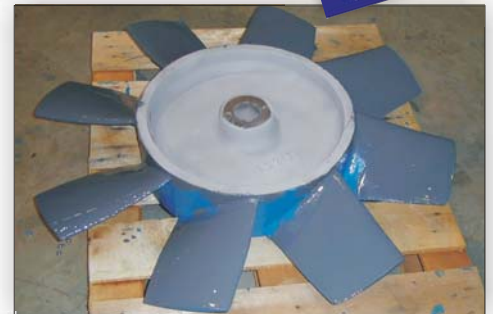
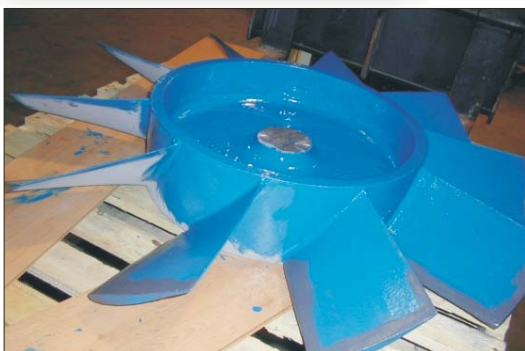
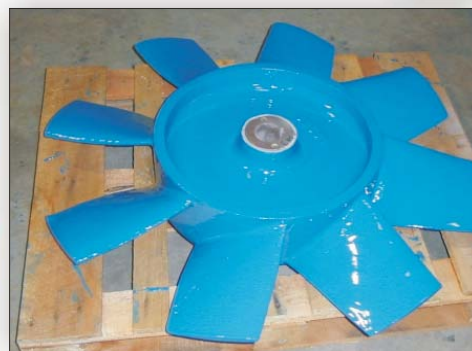
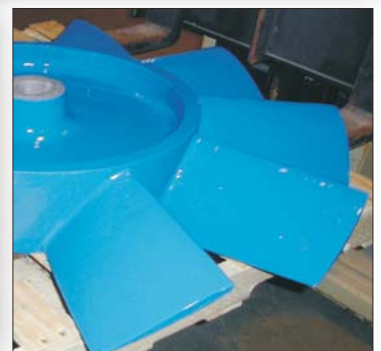
These aluminum air extraction blades had eroded due to the fine particles that were sometimes present in the air in the mine. The mine's maintenance

These step-by-step photos clearly illustrate the outstanding results.

engineers wanted a quick and cost effective method to repair these fan blades and provide them with long-term protection from future erosion damage. They selected

CeramAlloy CP+AC and CL+AC because of the ease of application and the outstanding erosion and corrosion resistance that the CeramAlloy system provides.
