Air Extraction Fan Blades From Australian Mining Operation Re-Built & Protected With CeramAlloy

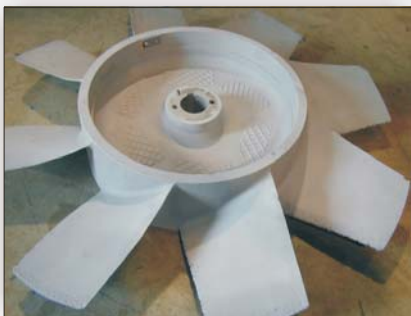
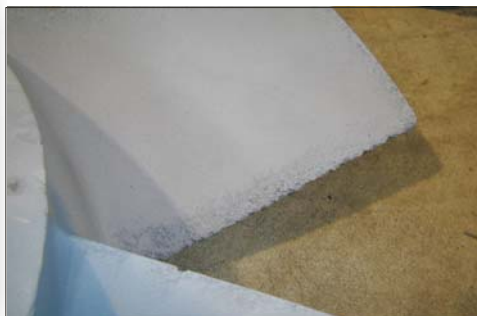
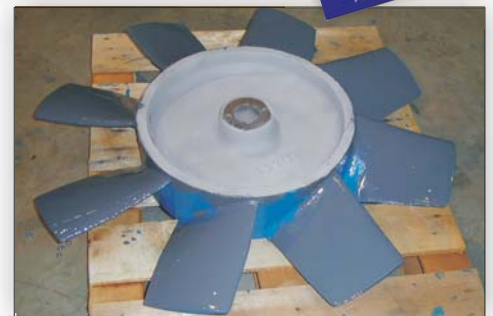
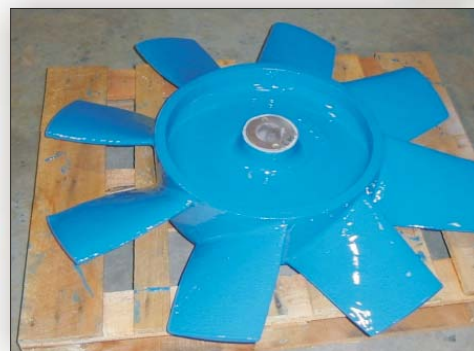
These aluminum air extraction blades had eroded due to the fine particles that were sometimes present in the air in the mine. The mine's maintenance

These step-by-step photos clearly illustrate the outstanding results.

engineers wanted a quick and cost effective method to repair these fan blades and provide them with long-term protection from future erosion damage. They selected

CeramAlloy CP+AC and CL+AC because of the ease of application and the outstanding erosion and corrosion resistance that the CeramAlloy system provides.
