## Spanish Nuclear Station Chooses CeramAlloy & DuraQuartz To Control Corrosion On Cooling Water Intake Lines

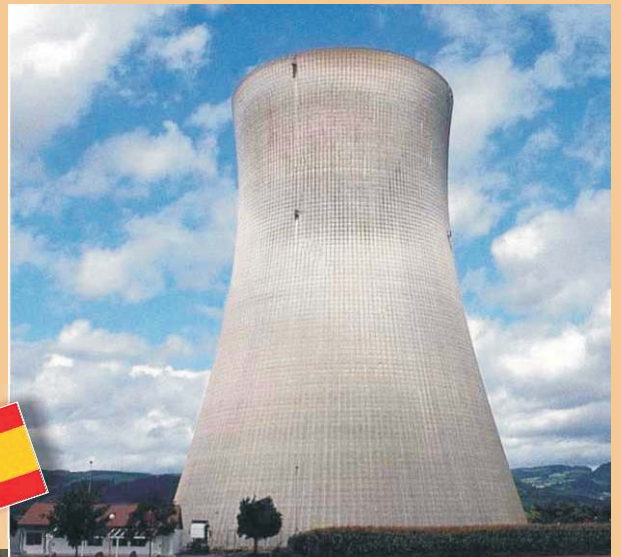
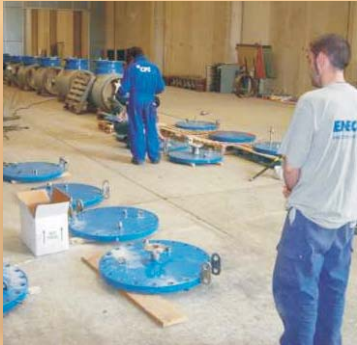
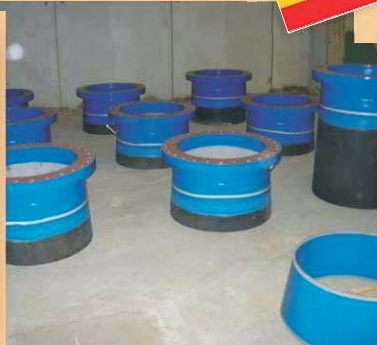
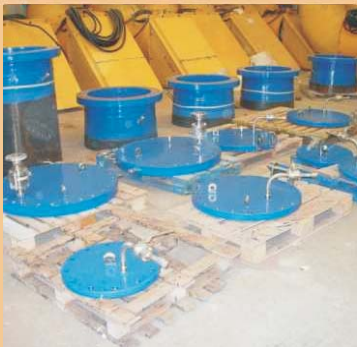
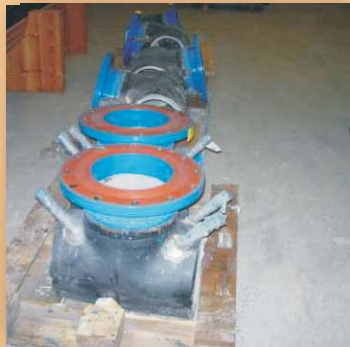
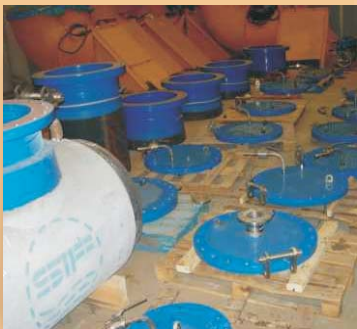
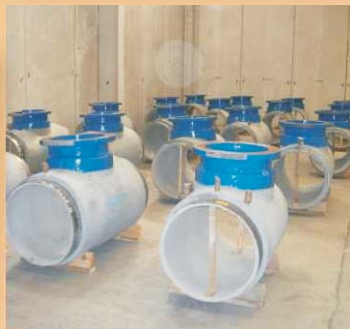
The maintenance engineers of this major nuclear power station were experiencing problems in their cooling water intake lines due to ineffective seals on the access manhole collars. The metal intake piping is encased in concrete and the existing design was allowing water to seep between the concrete shell and the metal core. This caused corrosion on the outside of the metal pipe.

The local ENECON Ibérica specialist recommended building up the joint between the metal collars and the concrete casing with DuraQuartz to prevent the water from getting behind the seal. After the DuraQuartz was applied, the collars were coated with two layers of CeramAlloy CL+(AC) to complete the application.

Upon reassembly, the station engineers were completely pleased when they saw that the leakage had been stopped and the corrosion problem eliminated.
