## Spanish Nuclear Station Chooses CeramAlloy & DuraQuartz To Control Corrosion On Cooling Water Intake Lines

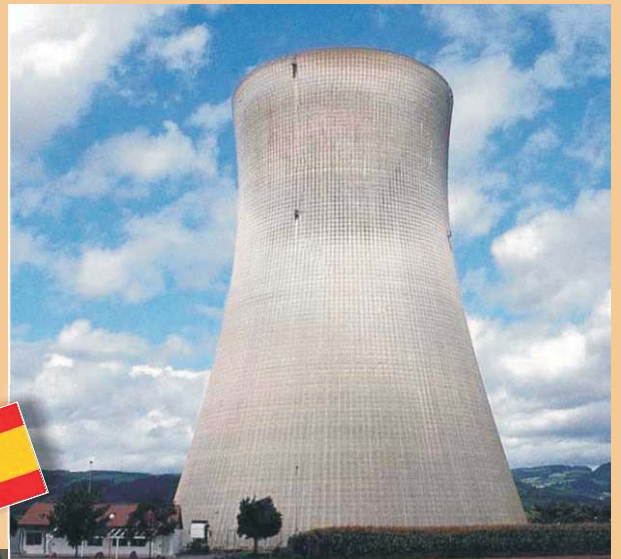
The maintenance engineers of this major nuclear power station were experiencing problems in their cooling water intake lines due to ineffective seals on the access manhole collars. The metal intake piping is encased in concrete and the existing design was allowing water to seep between the concrete shell and the metal core. This caused corrosion on the outside of the metal pipe.

The local ENECON Ibérica specialist recommended building up the joint between the metal collars and the concrete casing with DuraQuartz to prevent the water from getting behind the seal. After the DuraQuartz was applied, the collars were coated with two layers of CeramAlloy CL+(AC) to complete the application.

Upon reassembly, the station engineers were completely pleased when they saw that the leakage had been stopped and the corrosion problem eliminated.
