German Wastewater Treatment Facility Selects DurAlloy & CHEMCLAD To Repair Large Vertical Spiral Cage Pump

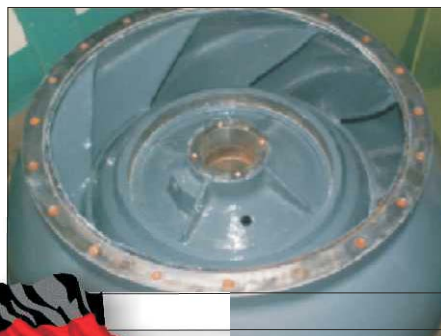
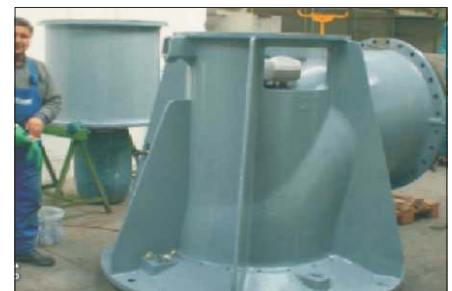
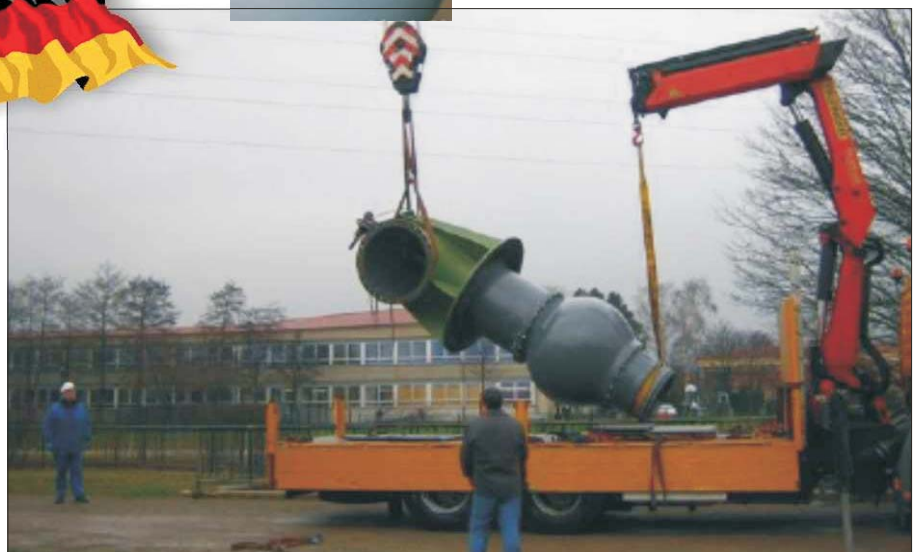
A major German wastewater treatment facility had experienced some corrosion damage on the guide veins of a large vertical spiral cage pump. The guide veins of the housing were severely damaged after some concrete blocks were accidentally left in the intake duct following some repair work.

NovoTech, the local ENECON Distributor in Germany, was called in to find a solution to this serious problem. It was decided that they would re-build the edges of the guide veins of the pump with DurAlloy. To enhance the strength of the DurAlloy, hexagonal screws were driven in to the edges of the damaged guide veins. Then DurAlloy was used to build up the edges.

After the DurAlloy had cured, the edges of the guide veins were ground to restore their original shape. The rest of the pump was then grit blasted both inside and out. Following the grit blasting, two coats of CHEMCLAD SC were applied. The inlet elbow of the pump was then painted green to match the color code of the facility.
