German Wastewater Treatment Facility Selects DurAlloy & CHEMCLAD To Repair Large Vertical Spiral Cage Pump

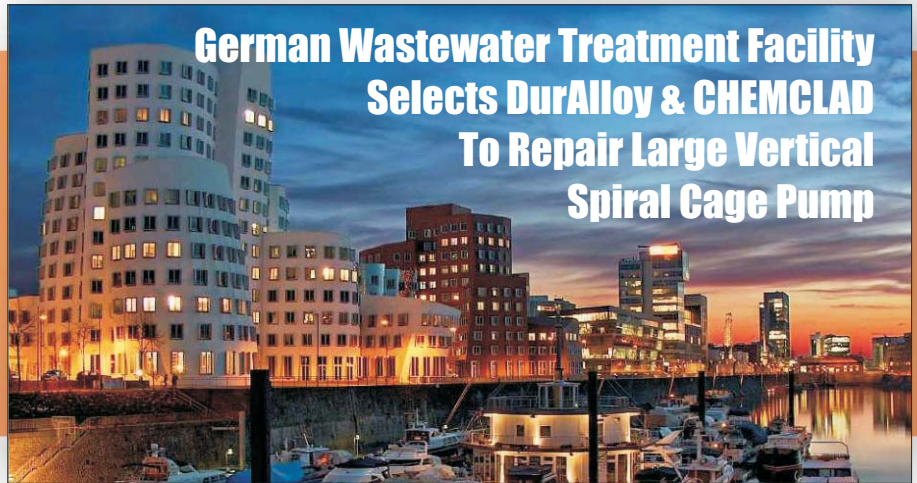
A major German wastewater treatment facility had experienced some corrosion damage on the guide veins of a large vertical spiral cage pump. The guide veins of the housing were severely damaged after some concrete blocks were accidentally left in the intake duct following some repair work.

NovoTech, the local ENECON Distributor in Germany, was called in to find a solution to this serious problem. It was decided that they would re-build the edges of the guide veins of the pump with DurAlloy. To enhance the strength of the DurAlloy, hexagonal screws were driven in to the edges of the damaged guide veins. Then DurAlloy was used to build up the edges.

After the DurAlloy had cured, the edges of the guide veins were ground to restore their original shape. The rest of the pump was then grit blasted both inside and out. Following the grit blasting, two coats of CHEMCLAD SC were applied. The inlet elbow of the pump was then painted green to match the color code of the facility.
