Main Paper Feed Stock Pump Repaired & Resurfaced With CeramAlloy & CHEMCLAD

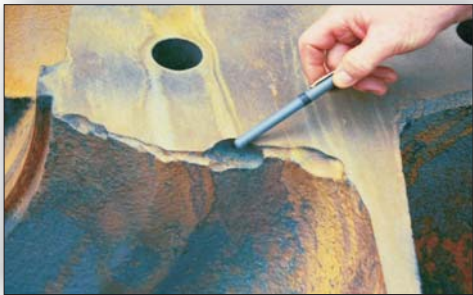
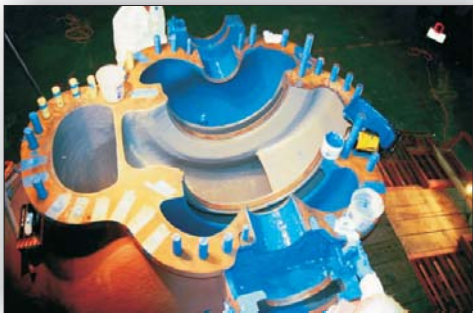
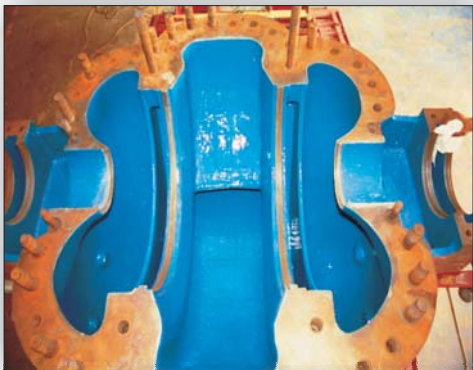
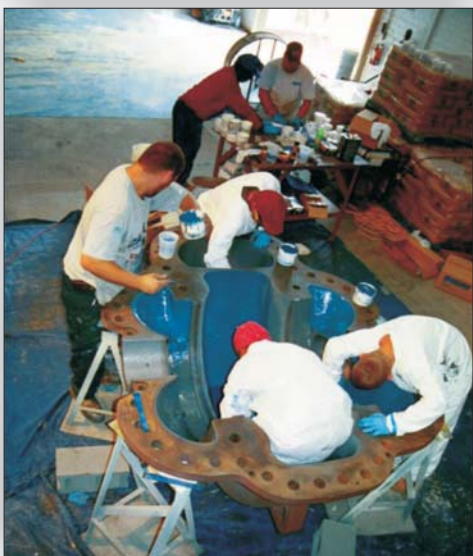
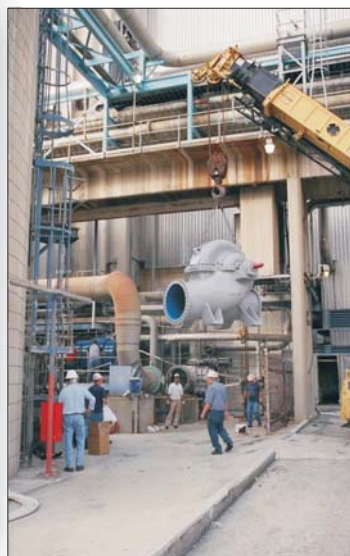
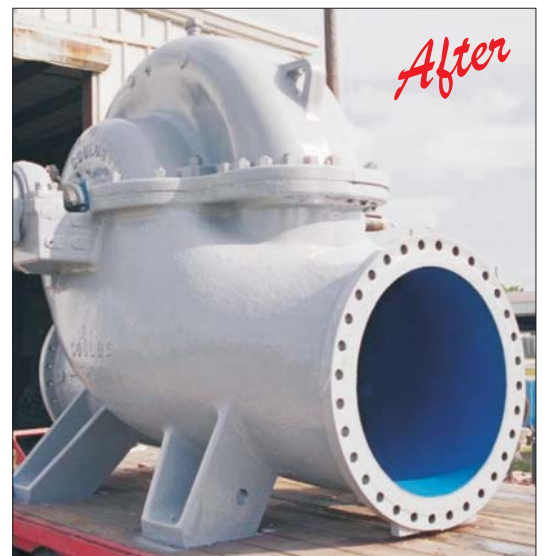
The plant engineers at this large paper mill located in North Carolina needed a cost effective and commercially proven repair solution for their 30-year old main paper feed stock pump which was severely eroded and corroded.

They suggested that all internal surfaces be repaired and resurfaced with CeramAlloy CP+AC and CL+AC. They then recommended that two coats of CHEMCLAD SC be used to protect all external surfaces from the aggressive paper mill environment.

This major project was successfully completed in just one week.

Since the plant has maintained detailed records of the pump's operation over the years they determined that the rebuilt and resurfaced pump was actually performing *more efficiently* than when it was first installed.
