Main Paper Feed Stock Pump Repaired & Resurfaced With CeramAlloy & CHEMCLAD

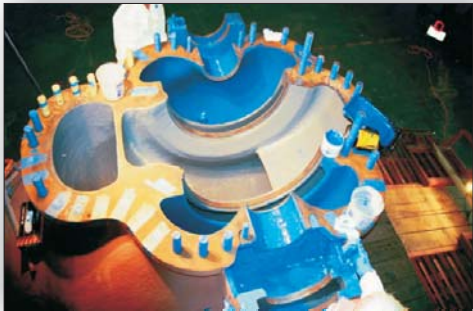
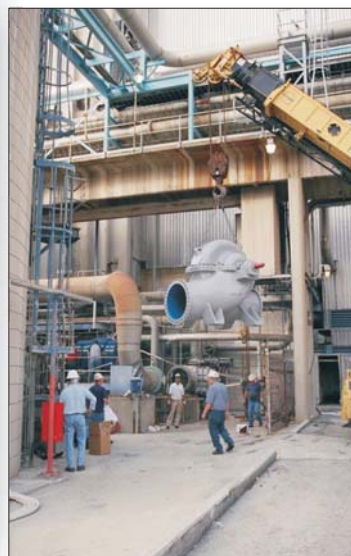
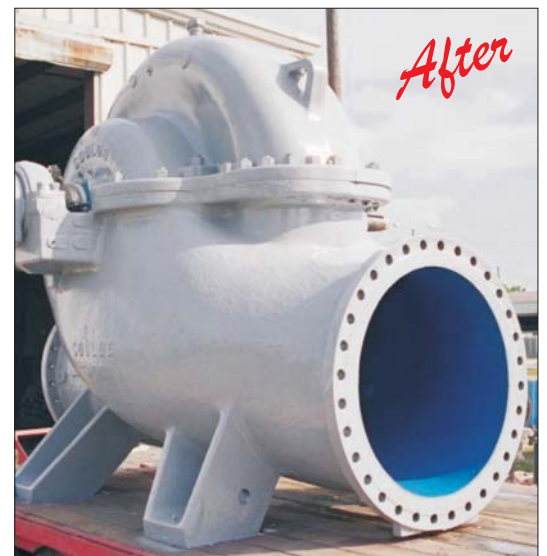
The plant engineers at this large paper mill located in North Carolina needed a cost effective and commercially proven repair solution for their 30-year old main paper feed stock pump which was severely eroded and corroded.

They suggested that all internal surfaces be repaired and resurfaced with CeramAlloy CP+AC and CL+AC. They then recommended that two coats of CHEMCLAD SC be used to protect all external surfaces from the aggressive paper mill environment.

This major project was successfully completed in just one week.
