CeramAlloy & DurAlloy Save Brazilian Paper Mill Thousands Of Dollars On Stock Pump Repair

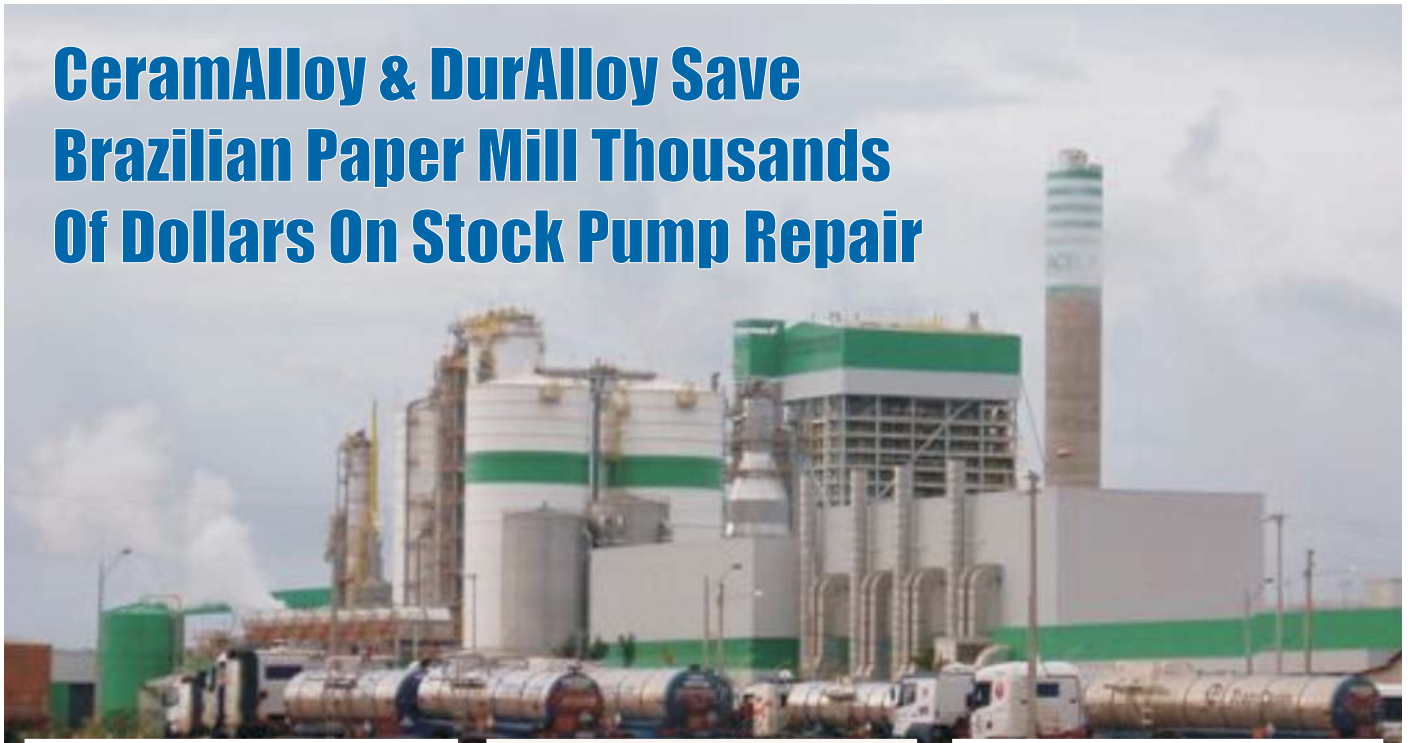
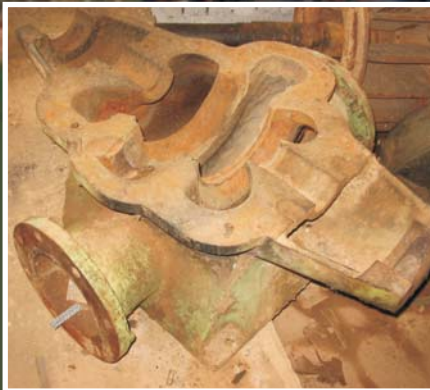
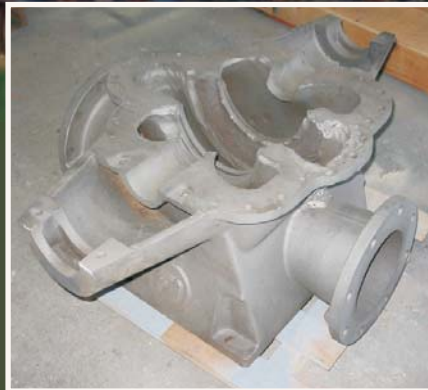
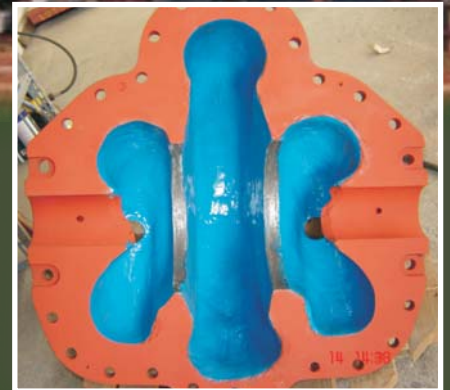
This Brazilian paper mill stock pump was severely damaged after 12 years of continuous use. The mill's engineers sent the pump out to two separate pump repair companies who advised that this pump was "unrepairable" and suggested replacement as the only viable option.

The ENECON Brazil Engineering Team was then contacted to see if they could tackle this project. They suggested a standard CeramAlloy/DurAlloy pump repair procedure. The plant's engineers agreed

and this pump was expertly repaired and protected from future erosion-corrosion damage in just a few days for less than 1/3 the cost of a new pump.
