CeramAlloy & DurAlloy Save Brazilian Paper Mill Thousands Of Dollars On Stock Pump Repair

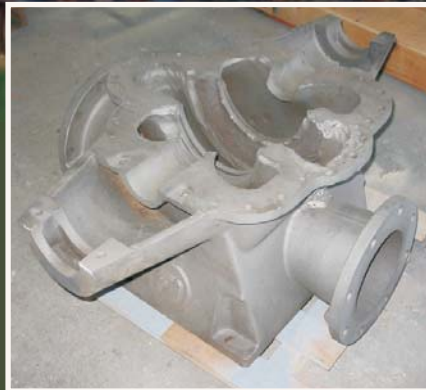
This Brazilian paper mill stock pump was severely damaged after 12 years of continuous use. The mill's engineers sent the pump out to two separate pump repair companies who advised that this pump was "unrepairable" and suggested replacement as the only viable option.

The ENECON Brazil Engineering Team was then contacted to see if they could tackle this project. They suggested a standard CeramAlloy/DurAlloy pump repair procedure. The plant's engineers agreed

and this pump was expertly repaired and protected from future erosion-corrosion damage in just a few days for less than 1/3 the cost of a new pump.
