## CeramAlloy Solves Cathodic Corrosion Problems On This Auto Ferry

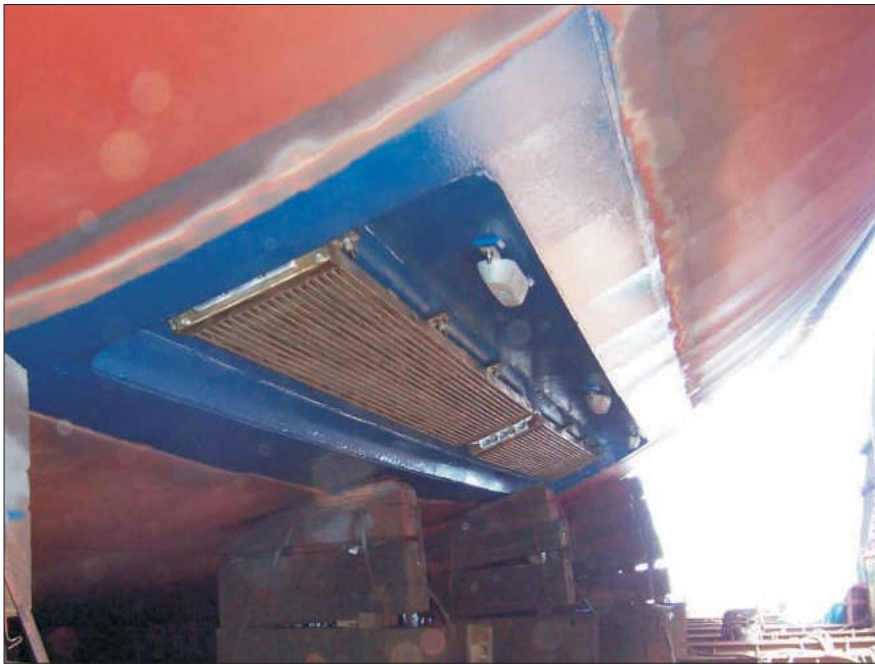
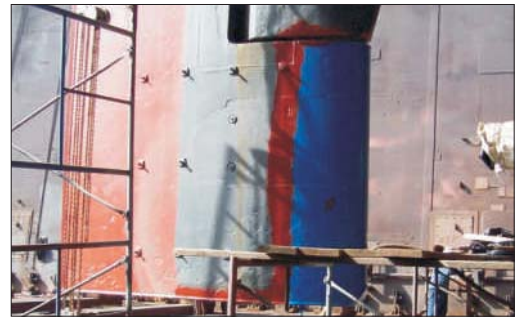
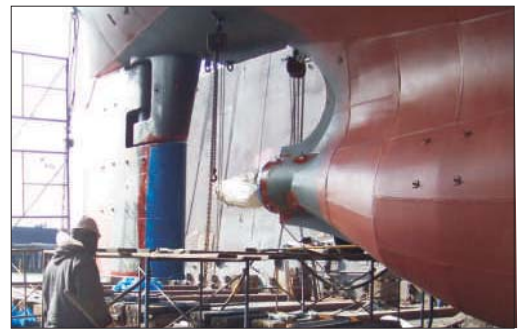
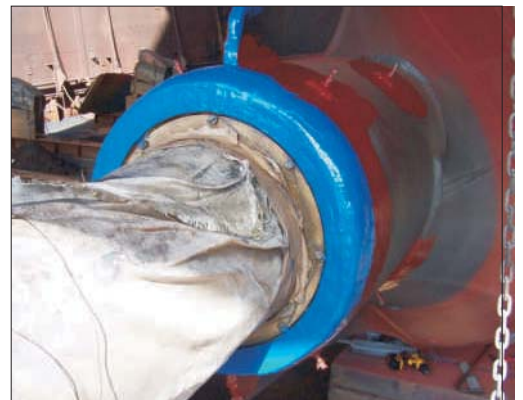
This large auto ferry had been experiencing severe cathodic corrosion damage in the keel cooler pockets. The ferry's engineers were unable to maintain proper cathodic protection with standard solid anode installations.

The ferry's rudders were also suffering from

erosion and impact damage.

After extensive preparation of the keel cooler pockets which

included grit blasting, a three-coat CeramAlloy CL+AC system was applied. The forward section of the rudders as well as the stern tubes were also coated.
