CeramAlloy Solves Cathodic Corrosion Problems On This Auto Ferry

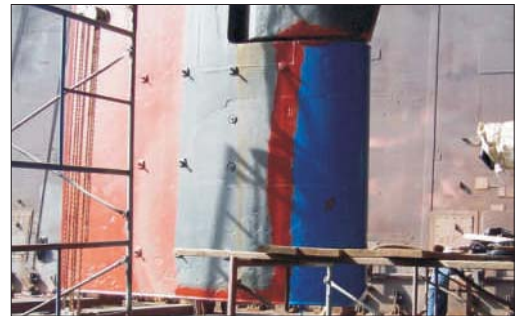
This large auto ferry had been experiencing severe cathodic corrosion damage in the keel cooler pockets. The ferry's engineers were unable to maintain proper cathodic protection with standard solid anode installations.

The ferry's rudders were also suffering from

erosion and impact damage.

The local ENECON Field Engineering Specialist recommended Metalclad CeramAlloy as a solution.

After extensive preparation of the keel cooler pockets which

included grit blasting, a three-coat CeramAlloy CL+AC system was applied. The forward section of the rudders as well as the stern tubes were also coated.
