## Major International Chemical Company Turns to ENECON for Help in Solving Serious Corrosion Issues

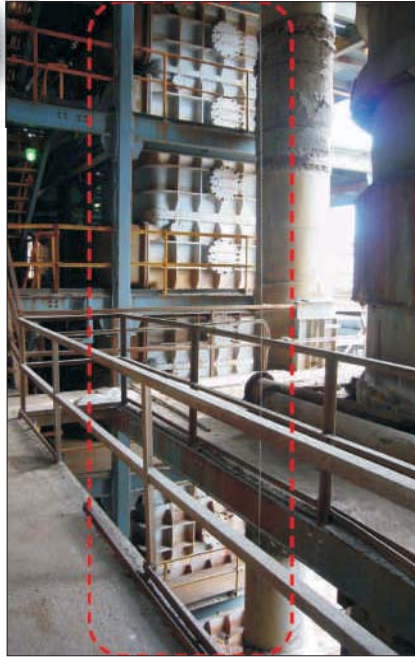
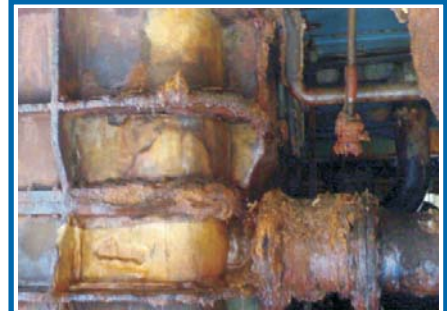
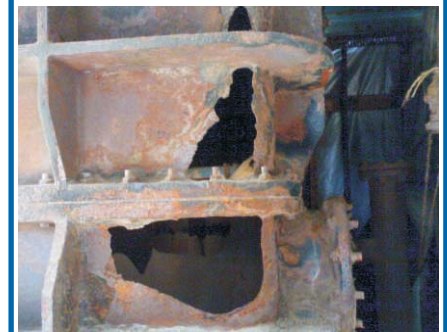
This 20-year-old preheater located at a soda ash manufacturing plant in India had been suffering from severe chemical attack and erosion damage.

ENECON India was contacted to help find a solution to this problem as well as to protect this preheater from future corrosion damage.

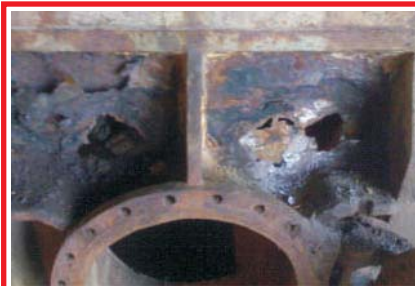
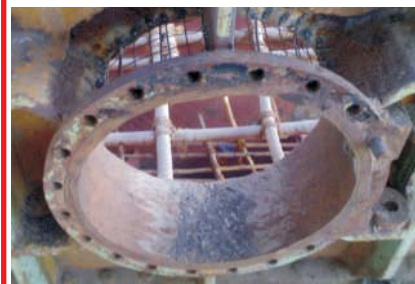
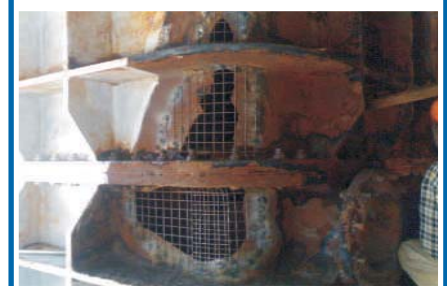
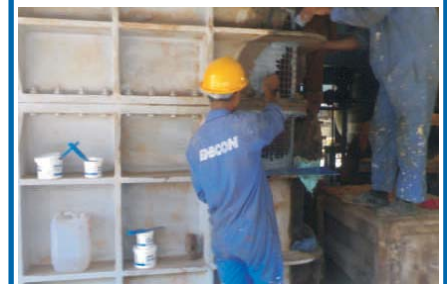
When the surfaces were grit blasted, large holes in the steel were uncovered and these had to be repaired immediately. Welding was not possible due to the potential for further damage to the thin metal surfaces. The ENECON field engineers, therefore, recommended an unconventional repair procedure: stainless steel wire mesh was used to bridge the large holes in the steelwork and **DurAlloy** (224 kg.) was used to permanently repair these areas.

After all holes were repaired, 2 coats of **ENESEAL CR** (280 kg.) were used to protect all of the exterior surfaces from the aggressive environment at this facility.

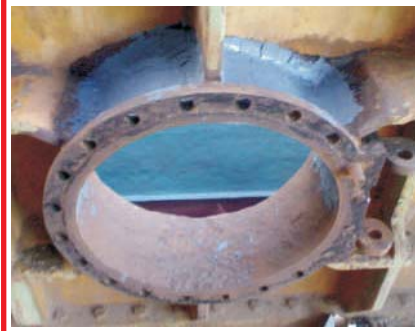
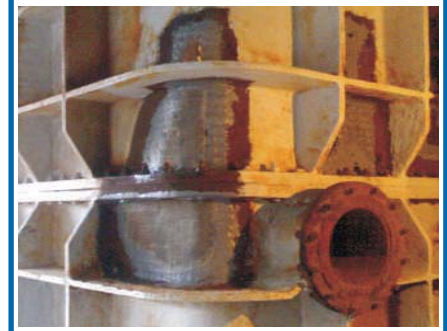
The plant's management was extremely satisfied with the outcome of this project. This preheater was put back into service immediately and preparations are being made to repeat this repair/protection project on another of the plant's preheaters.
