Major International Chemical Company Turns to ENECON for Help in Solving Serious Corrosion Issues

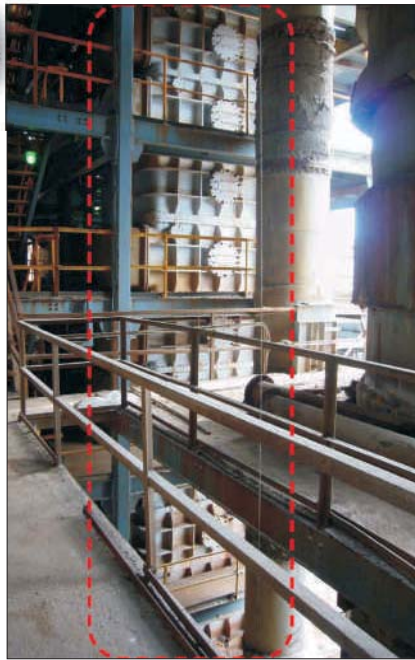
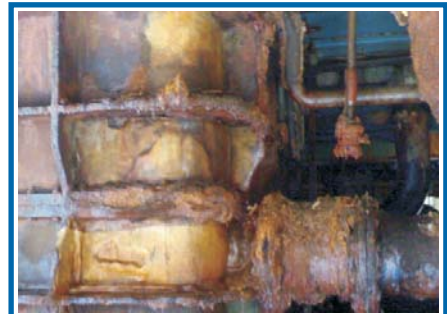
This 20-year-old preheater located at a soda ash manufacturing plant in India had been suffering from severe chemical attack and erosion damage.

ENECON India was contacted to help find a solution to this problem as well as to protect this preheater from future corrosion damage.
