## Major Power Plant Located in the Northeastern U.S. Selects CeramAlloy Pipe Wrap System to Repair this Main Cooling Water Intake Pipe

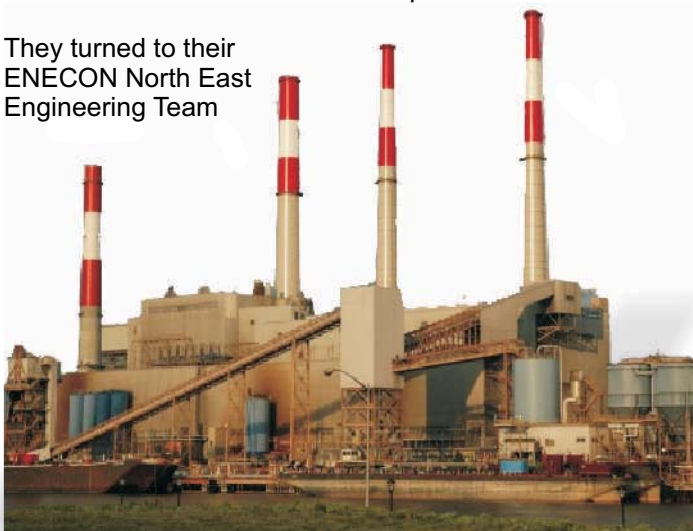
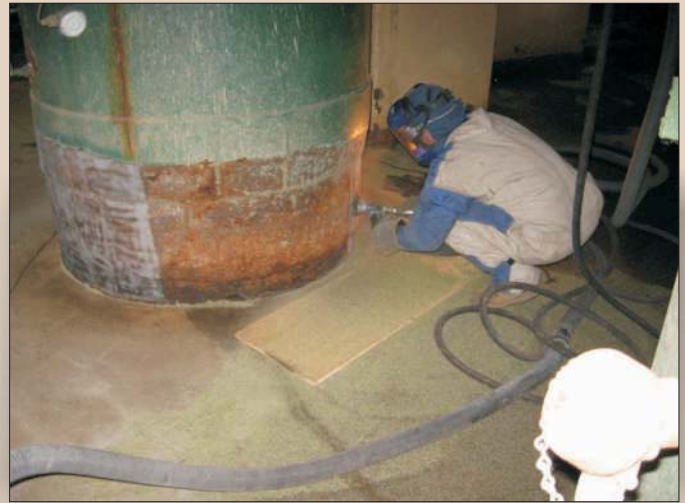
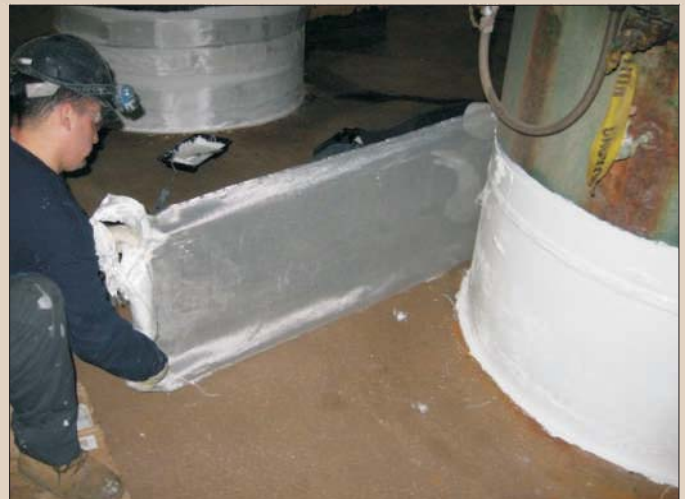
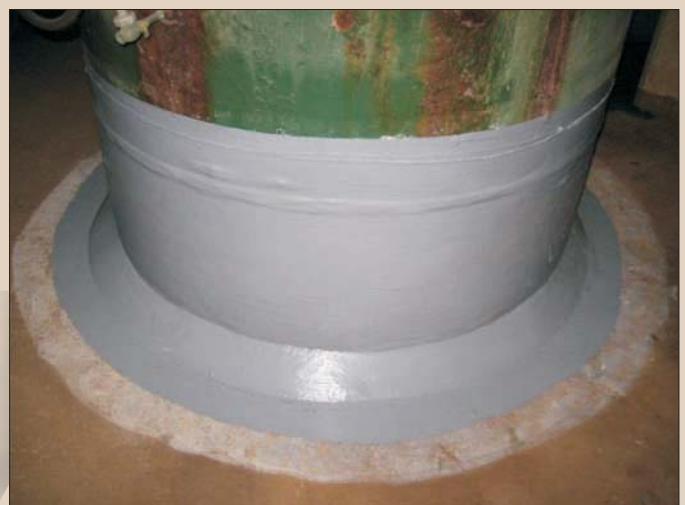
The maintenance engineers at this large oil fired power plant needed an unconventional approach to repairing and reinforcing a damaged section on one of their main cooling water intake pipes.

They could not shut down the plant for an extended replacement procedure and they were concerned that a conventional welding repair could damage the pipe further since it was already worn thin by years of erosion and corrosion attack in the brackish water environment.

After preparing the surface by grinding and wire-brushing, **SuperBond** was applied to insure optimum adhesion. This was followed by the application of multi layers of **CeramAlloy** and special reinforcement cloth to completely encapsulate this pipe section, thus providing a long-term repair. This \$10,000 project took just a couple of days to complete.
