## California Power Plant Salvages Main Cooling Water Inlet Pipes with a CeramAlloy Pipe Wrap System

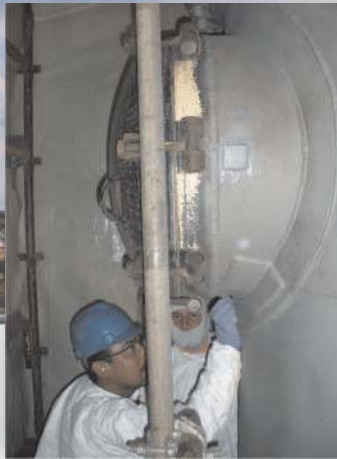
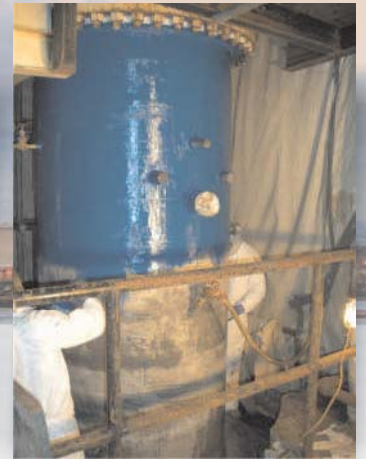
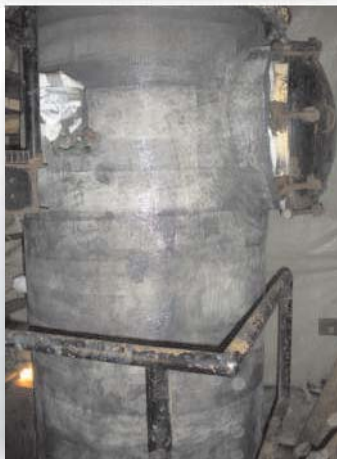
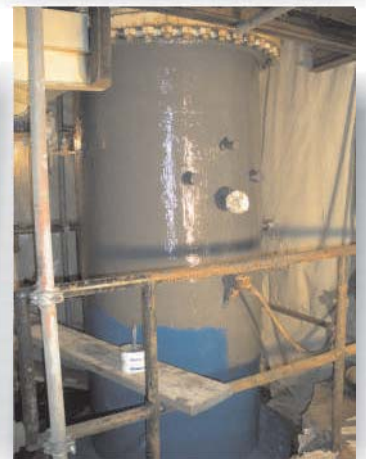
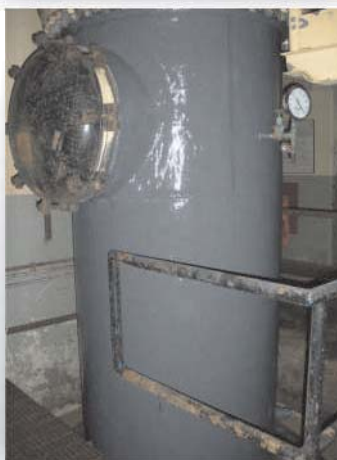
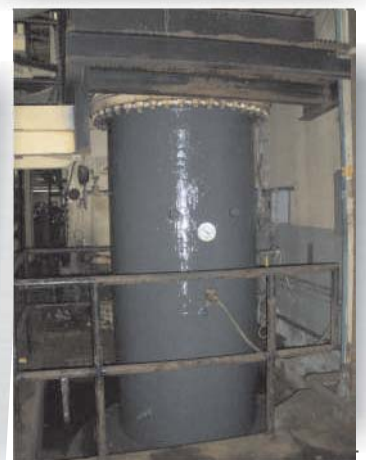
The engineers at this large power station in California identified a serious problem with their two main cooling water inlet pipes which were severely corroded due to many years of operation in a coastal marine environment.

After first grit-blasting these 4-foot diameter pipe sections, any serious corrosion

damage - including a number of actual holes in the pipes – was first repaired with DurAlloy and metal plates.

A layer of **CeramAlloy CL+AC** was then applied over the entire pipe section followed by a spiral wrap of a special reinforcement fabric. This was then completely encapsulated by an additional two layers of CeramAlloy CL+AC to complete the pipe wrap system.

This procedure was completed in just a few days and at a fraction of the cost that would have been incurred to replace these large pipe sections.
