California Power Plant Salvages Main Cooling Water Inlet Pipes with a CeramAlloy Pipe Wrap System

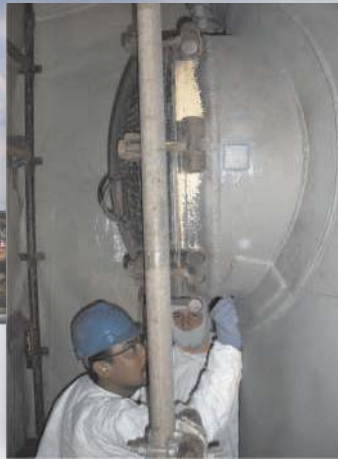
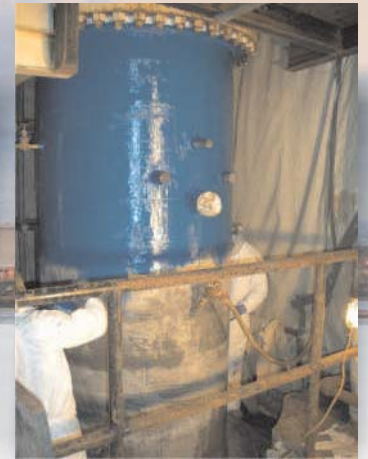
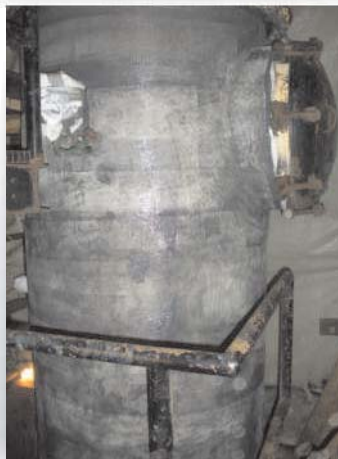
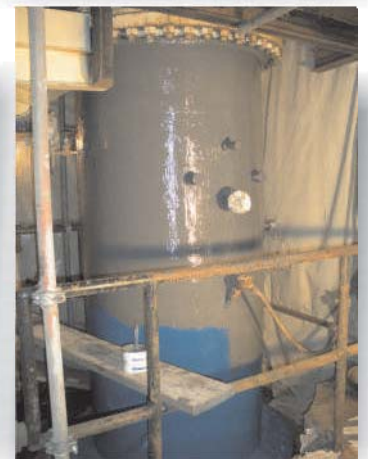
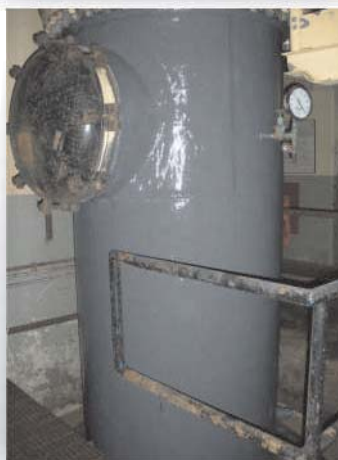
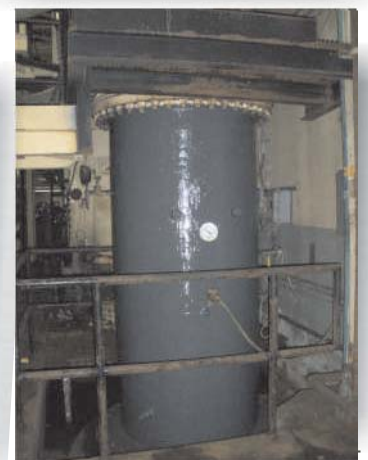
The engineers at this large power station in California identified a serious problem with their two main cooling water inlet pipes which were severely corroded due to many years of operation in a coastal marine environment.

After first grit-blasting these 4-foot diameter pipe sections, any serious corrosion

damage - including a number of actual holes in the pipes – was first repaired with DurAlloy and metal plates.

A layer of **CeramAlloy CL+AC** was then applied over the entire pipe section followed by a spiral wrap of a special reinforcement fabric. This was then completely encapsulated by an additional two layers of CeramAlloy CL+AC to complete the pipe wrap system.

This procedure was completed in just a few days and at a fraction of the cost that would have been incurred to replace these large pipe sections.
