## CeramAlloy 'Rescues' Italian Passenger Ferry Thruster Tunnels

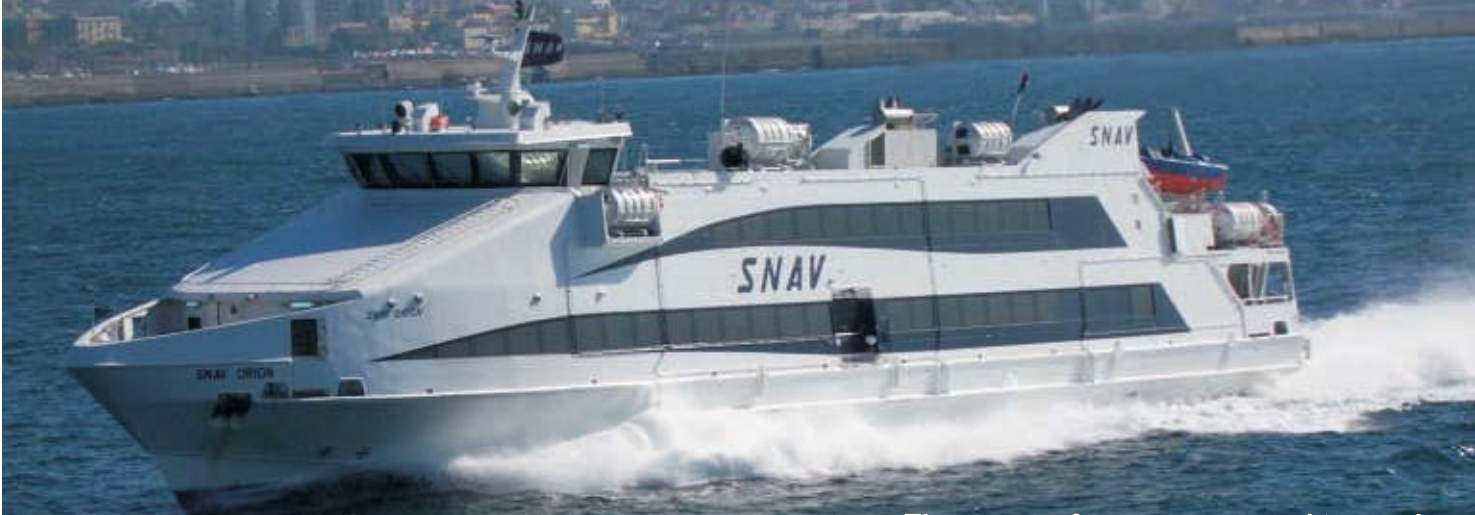
*Before*

*After*

The owner of an Italian passenger ferry fleet had been experiencing corrosion damage on the aluminum thruster tunnels on one of his ships.

Several attempts to repair and protect these tunnels were made using conventional coatings. These failed after only three months!

ENECON Italia was contacted to help find a cost effective, yet long-lasting solution. After first preparing these tunnels, CeramAlloy CP+AC

was used to repair all pitted surfaces, followed by 2 coats of CeramAlloy CL+AC to provide long-term protection.

After 1 year, during routine maintenance, it was discovered that the CeramAlloy was in excellent condition and needed only minimal spot repairs due to physical damage.
