DurAlloy & ENESEAL CR Salvage Fume Extraction System at Canadian Steel Mill Saving \$100k & Reducing Emissions

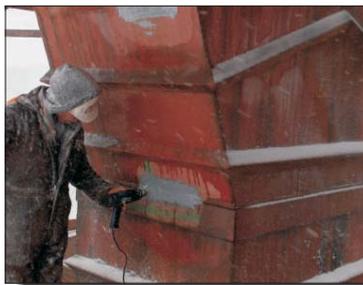
SpeedAlloy being applied.

ENECON Ontario was contacted to help find a fast and long lasting solution. Test patches of **SpeedAlloy** were applied to some of the duct's larger holes. The mill's engineers were so pleased with the results of the test patches it was decided that the entire duct section be encapsulated with

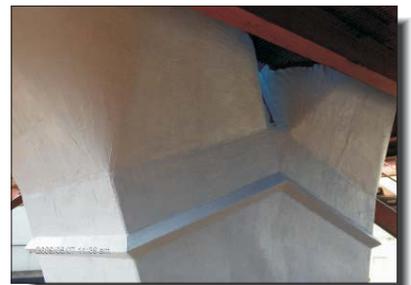
DurAlloy applied over entire extractor shell.

DurAlloy. As a final measure the unit was coated with **ENESEAL CR** for optimum corrosion resistance and a uniform look.

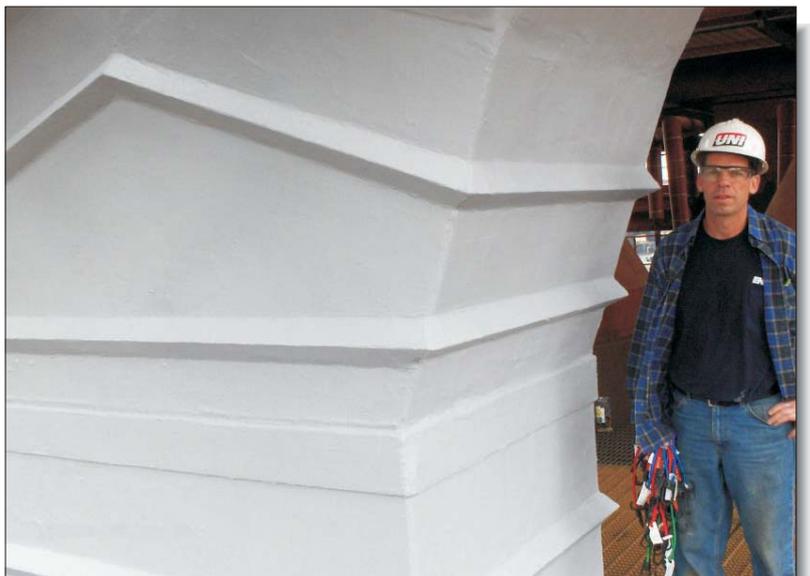
After totally encapsulating the unit in DurAlloy, ENESEAL CR was used to provide optimum corrosion resistance and a uniform look.
