FLEXICLAD ER® Repairs Rubber Covered Drive Shaft at Wastewater Treatment Facility

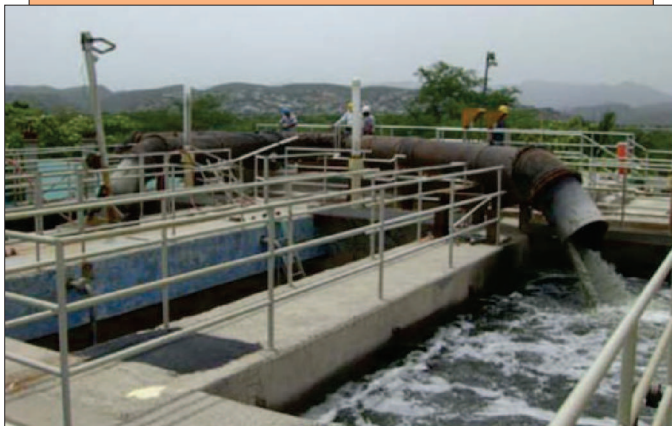
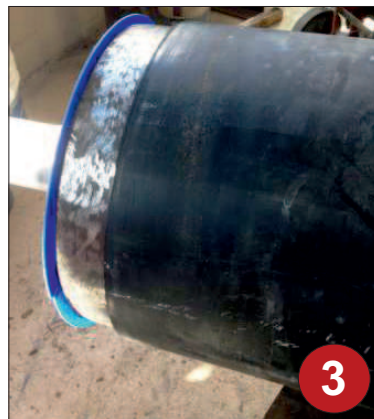
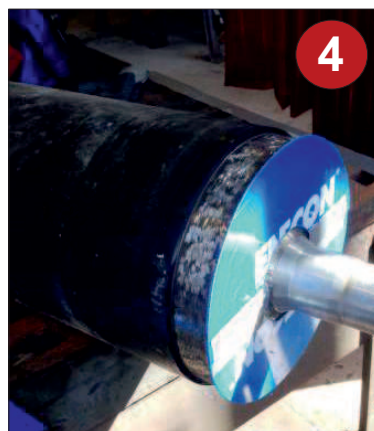
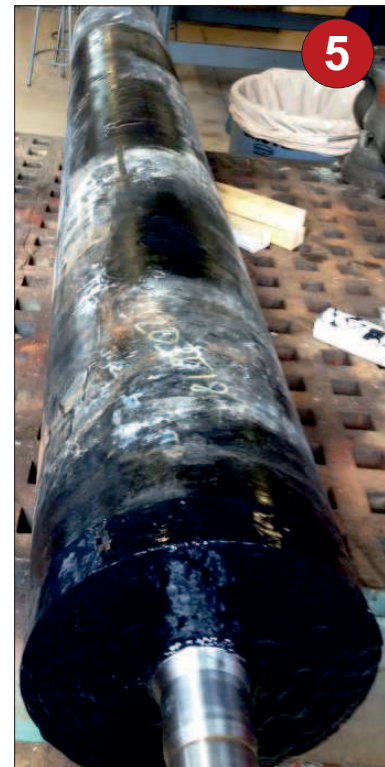
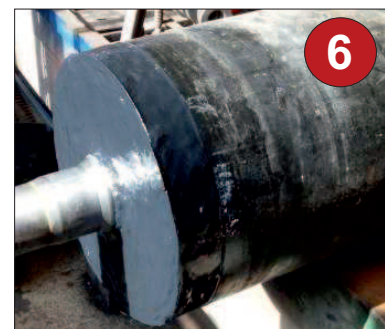
The end of this 10 inch diameter drive shaft, used on the belt system for de-watering the 'floc' at this wastewater treatment facility, had to undergo some welding repairs. The existing rubber shaft covering had to be cut back to allow for the welding process.

The plant engineers needed to get the system running so they turned to their local ENECON Field Engineering Specialist for help. He suggested using FLEXICLAD ER to rebuild the exposed end – providing a seamless rubber finish on the shaft.

A plastic former was created (an ENECON mixing board was used for this) to help in the rebuilding process. After grinding the metal, a ¼ inch of FLEXICLAD ER was applied to re-finish the shaft end. After 30 minutes, the former was removed and more FLEXICLAD ER was applied to complete the repair on the exposed end of the shaft.

This entire project was successfully completed in just one day saving the plant thousands of dollars in down-time associated with conventional rubber repairs which would have taken 3+ weeks.
