Popular Cocktail Bar In Cyprus Uses ENECRETE DuraFill To Repair Crumbling Floor

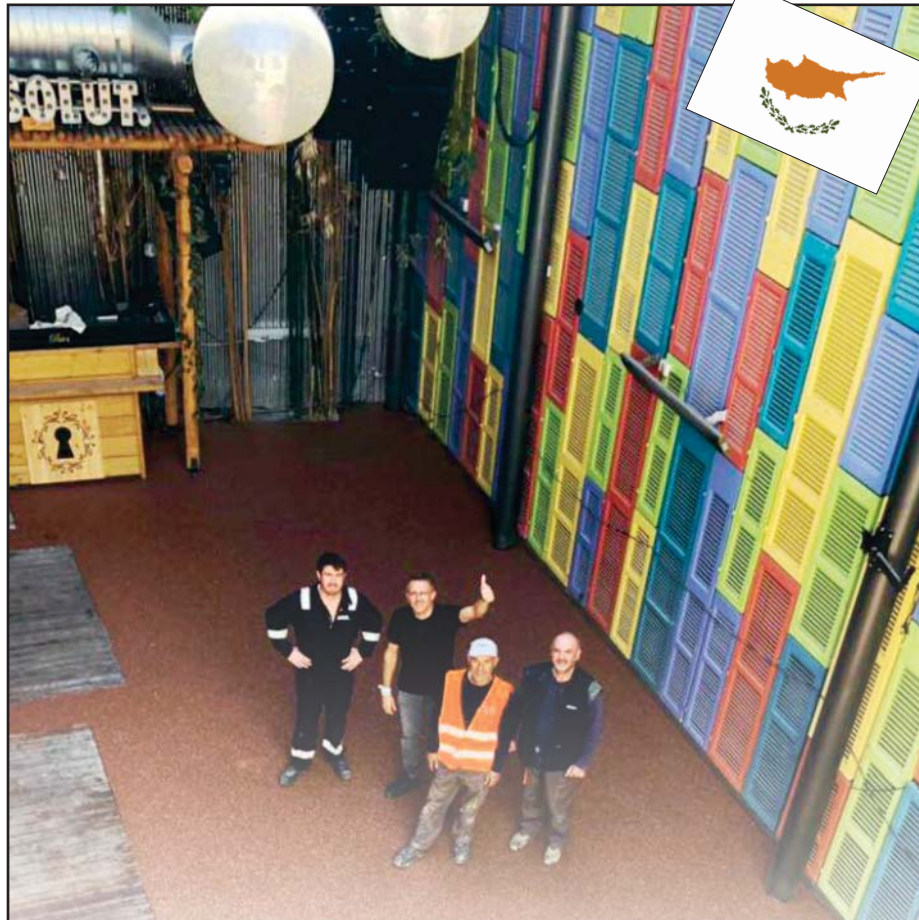
DuraFill and decorative stone is applied

The flooring material at this cocktail bar in Cyprus was deteriorating and coming loose. This was both unsightly and a potential tripping hazard. The bar's owners needed to find a quick and effective solution to solve this problem.

The existing, failing flooring material was removed and the

concrete substrate was cleaned and left to dry. **ENECRETE DuraFill** was applied by brush and roller to the concrete as a primer. The owners had chosen a decorative stone that was mixed with the *DuraFill* and applied to the floor. Once this step of the application was completed, a layer of *Durafill* resins was rolled onto the floor to seal it and provide maximum protection.

Within 48 hours ENECON Cyprus was able to deliver the bar's owners a completely new floor that not only looked great but also had much better resistance to foot traffic and spilled drinks than the previous material.
