## Russian Fertilizer Plant Solves Floor Problems with ENECLAD<sup>®</sup> and CHEMCLAD<sup>®</sup>

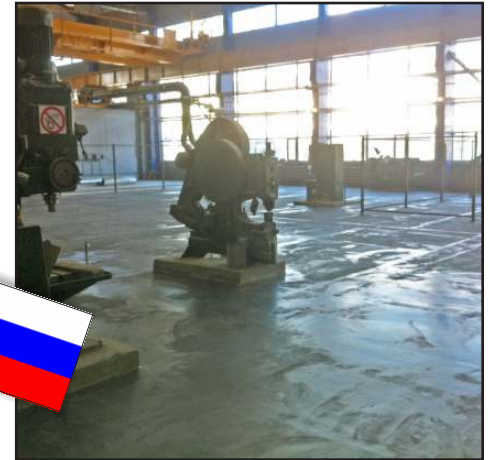
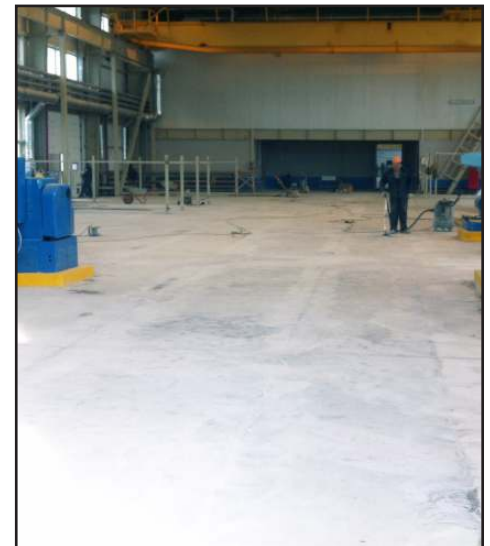
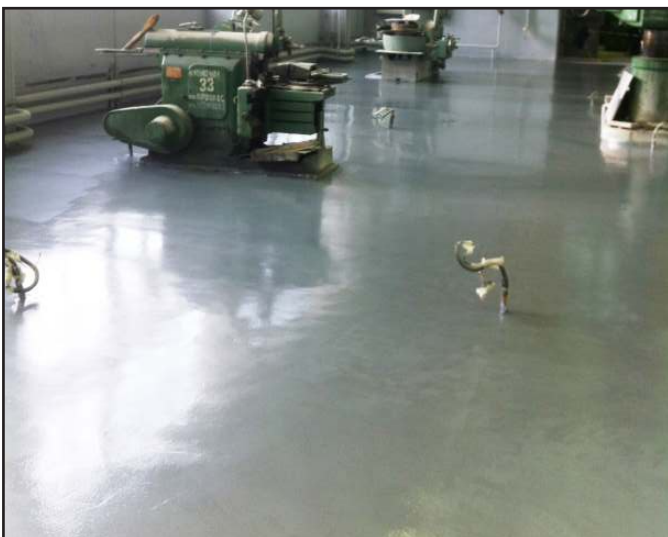
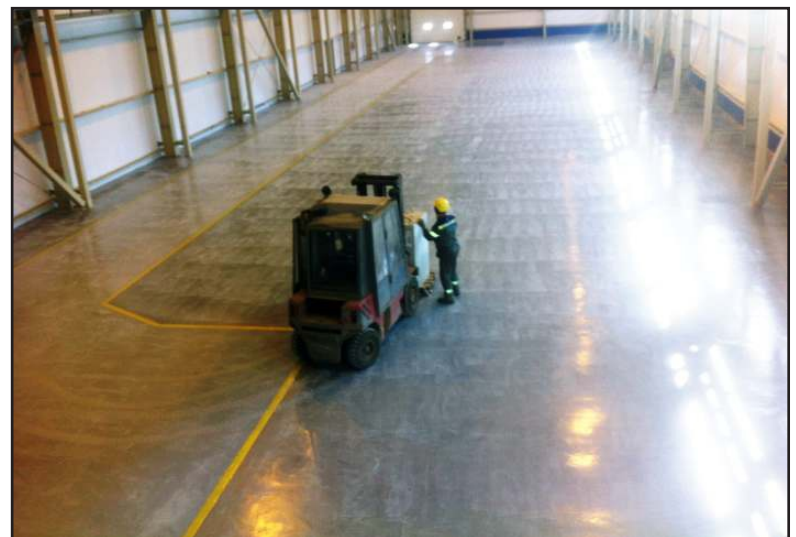
One of the largest chemical companies in Russia – a leader in the production of nitrogen fertilizers – had a number of problem floor issues totaling 90,000 sq. ft.

After sanding/grinding and cleaning the floors, all cracks were repaired with ENECLAD CFS with locally sourced quartz sand added in. Once cured, the cracks were sanded and all dust was removed.

All driveway areas were coated with two coats of CHEMCLAD SC with non-skid aggregates broadcast and back-rolled into the first coat.

The remaining floor areas were treated with

two coats of ENECLAD CFS – the first coat was tinted with a gray pigment and the second coat was left clear.

Yellow markings were done with DuraFill and yellow colored sand. Once cured, excess sand was removed and a top coat of ENECLAD CFS was then applied to seal the striping.
