ENESEAL CR Prescribed to Repair Northern California Hospital's Cooling Tower Piping & Electrical Cabinets

Client: Northern CA Hospital

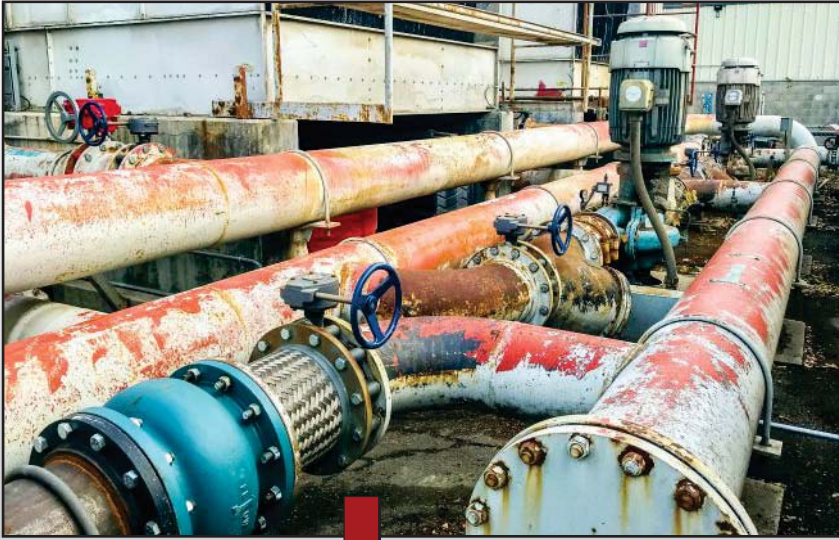
Problem: Due to neglect and lack of maintenance, these cooling tower pipes and electrical cabinets were suffering from severe corrosion.

Solution: Extremely corroded areas were prepared by wire wheel brush followed by high pressure washing. Two coats of **ENESEAL CR** were then spray-applied providing years of corrosion and UV protection.
