This Francis Turbine, operating at a 660 foot head, was experiencing continuing cavitation problems - requiring expensive weld repairs after every season.

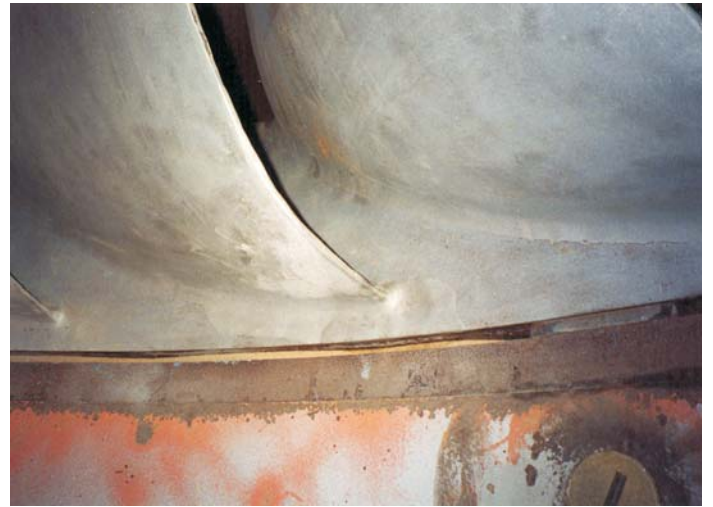
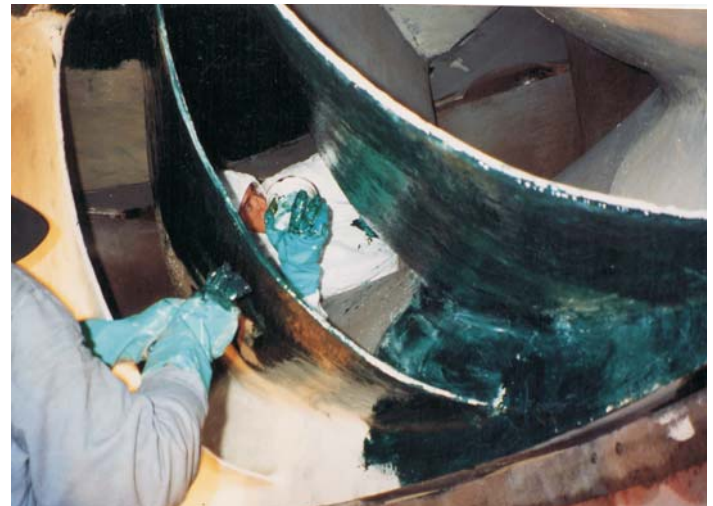
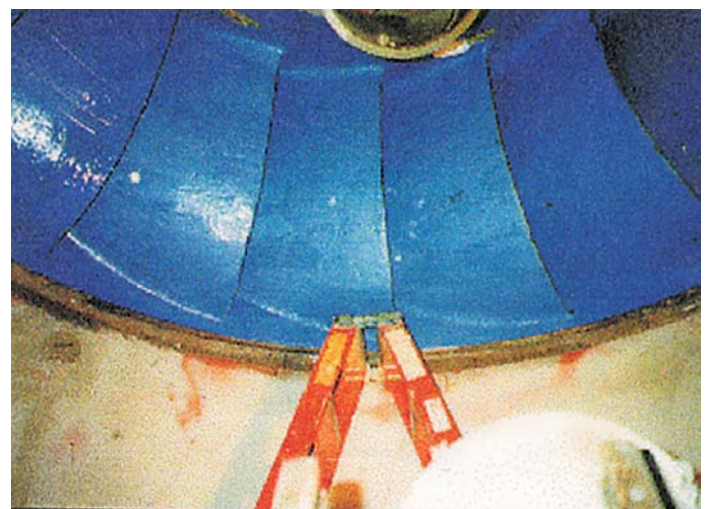
When opened next for inspection, after operating for some 13 months, the **DuraTough was found in perfect condition** in over 95% of the area treated. While there was some minor damage to the coating, this was limited to only three small areas on each blade - representing about 5% of the overall area that had been treated.

These areas were easily repaired and protected with the DuraTough; and, the unit was back in service and running for yet another season.
