DuraTough Solves Vacuum Leak Problems on Main Steam Condenser at Major Power Plant

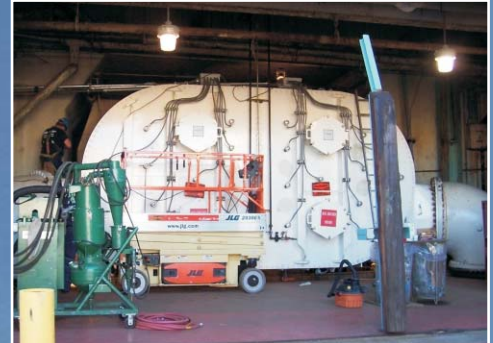
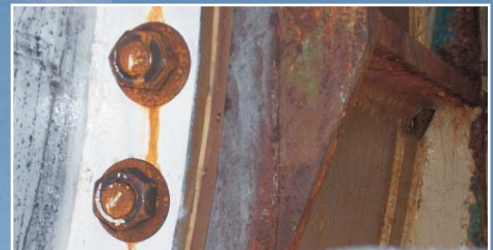
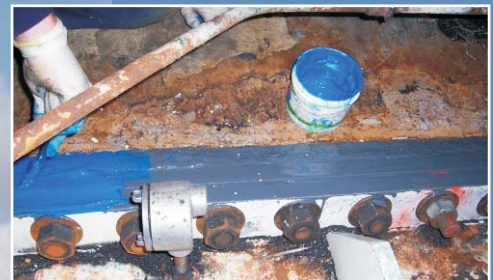
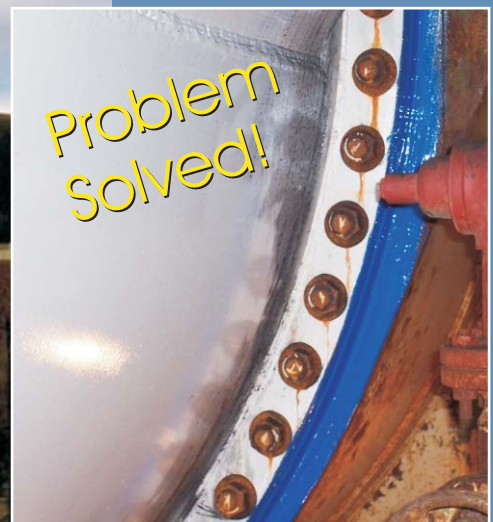
This large power station located in the Northeastern United States experienced serious air leakage in their main steam condenser. The source of the leaks was traced to the tube sheet to shell to hot well sandwich joints located where the inlet and outlet water boxes are bolted to the tube sheets/condenser shell.

The ENECON Northeast Engineering Team proposed to prepare the face of the bolted joints by

abrasive blasting to remove rust and provide for the best possible adhesion of the DuraTough DL system.

DuraTough Primer was applied, followed two coats of DuraTough DL with a fiberglass reinforcing mesh incorporated into the DuraTough DL.

Approximately 1/8 inches of DuraTough was applied to provide complete sealing to the joints.
