FLEXICLAD Repairs Cavitated Pump in Puerto Rico

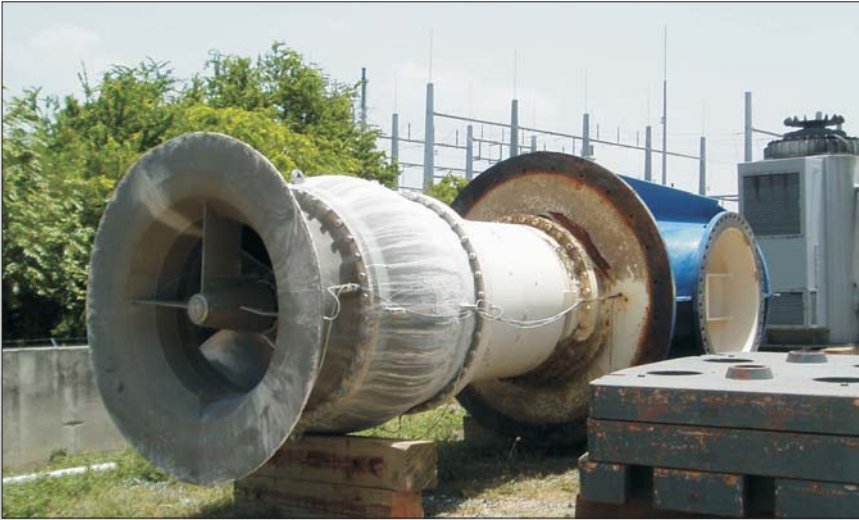
The stainless steel impeller of this large pump, located at a waste water treatment facility in Puerto Rico, was suffering from severe cavitation. The facility engineers needed a fast, reliable as well as cost-effective repair. The local ENECON Distributor was contacted to help find a solution.

It was decided that the impeller would first be prepared by grit blasting, followed by all cavitated areas being rebuilt with **DuraTough DP**.

The impeller was then protected from future cavitation damage with **DuraTough DL**.

In addition, **CeramAlloy CL+AC** was also used to protect the impeller's edges. **CeramAlloy CP+AC** and **CL+AC** were also used to rebuild and protect the pump casing which had significant corrosion damage.
