## Pennsylvania Hospital Stops Leaking Dishwashing Tray Seams in their Kitchen with FLEXICLAD ER

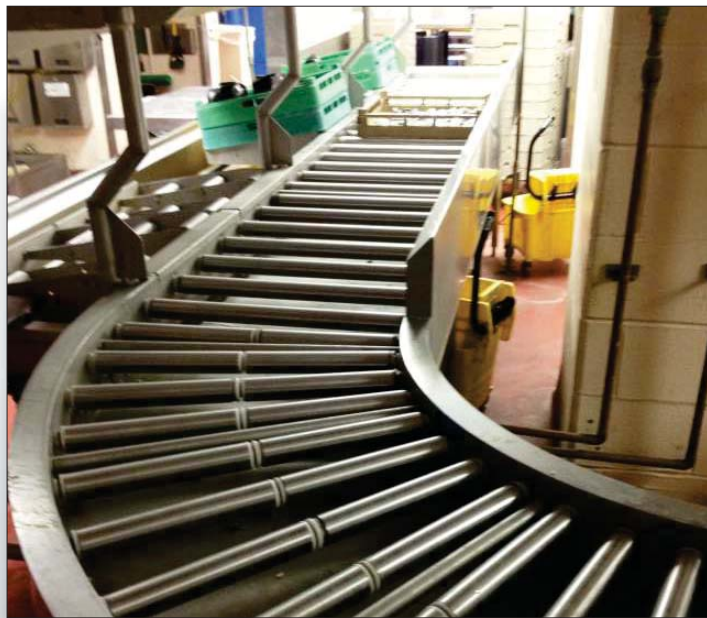
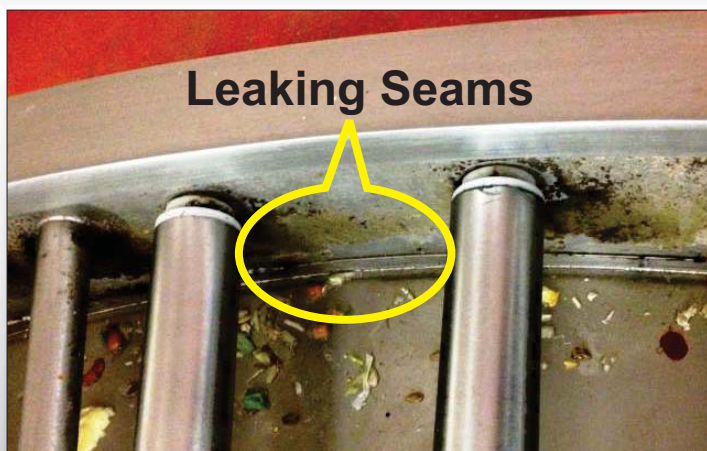
The hospital's maintenance engineers contacted the local ENECON Fluid Flow Systems Specialist with what they considered an 'unusual' problem. The seams of their stainless steel dishwashing tray line were leaking. This was causing slip/fall accidents, constant clean-up and generally unsanitary conditions.

The area's were manually prepared with sandpaper, then cleaned thoroughly. FLEXICLAD ER was applied, with no primer needed. The area was ready to be put back into action the next morning with no odor and no downtime.
