ENECON Provides Emergency Repairs With CHEMCLAD, DurAlloy & CeramAlloy To Paper Mill Water Box

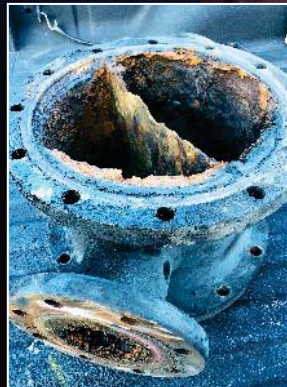
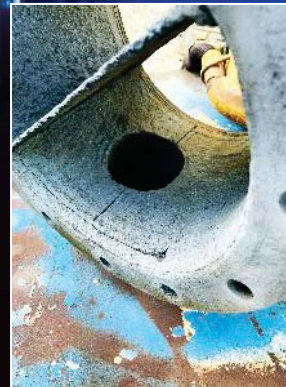
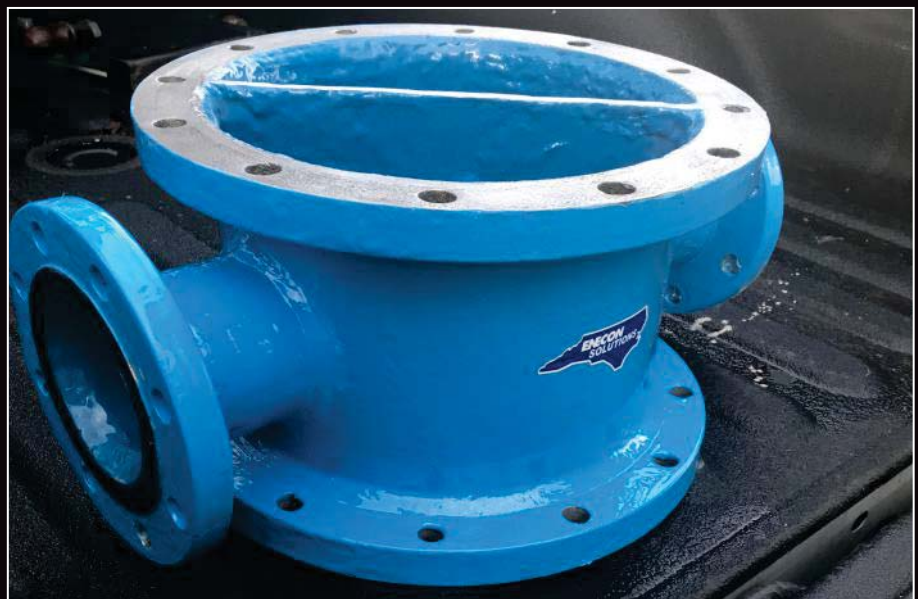
The divider bar on a small, but critical, chiller water box located at a North Carolina paper mill had completely corroded and was no longer functional in the process equipment it served. The mill's options to solve this problem were limited.

The water box was degreased, pressure washed then abrasive blasted. DurAlloy and a backer plate were used to rebuild the divider bar.

One coat of CeramAlloy CL+AC in gray was used on the internal side followed by a second coat of CeramAlloy CL+AC in blue to finish the interior as well as the exterior of the water box.
