Municipal Storm Water Drain Pump Repaired & Protected With CeramAlloy

ENECON® NEWS

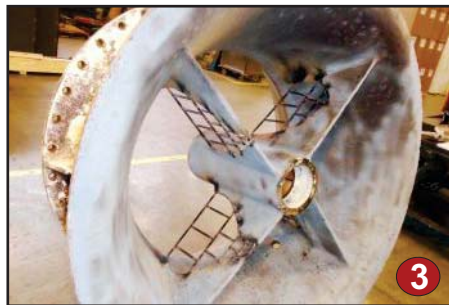
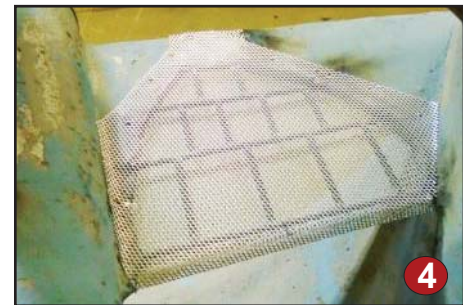
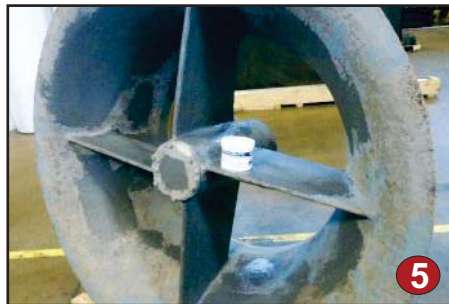
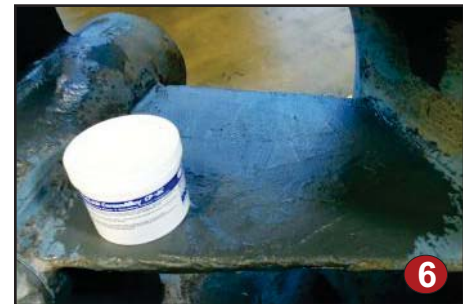
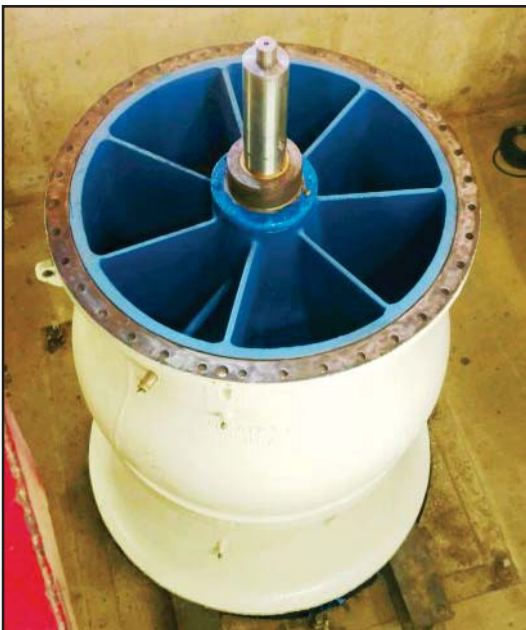
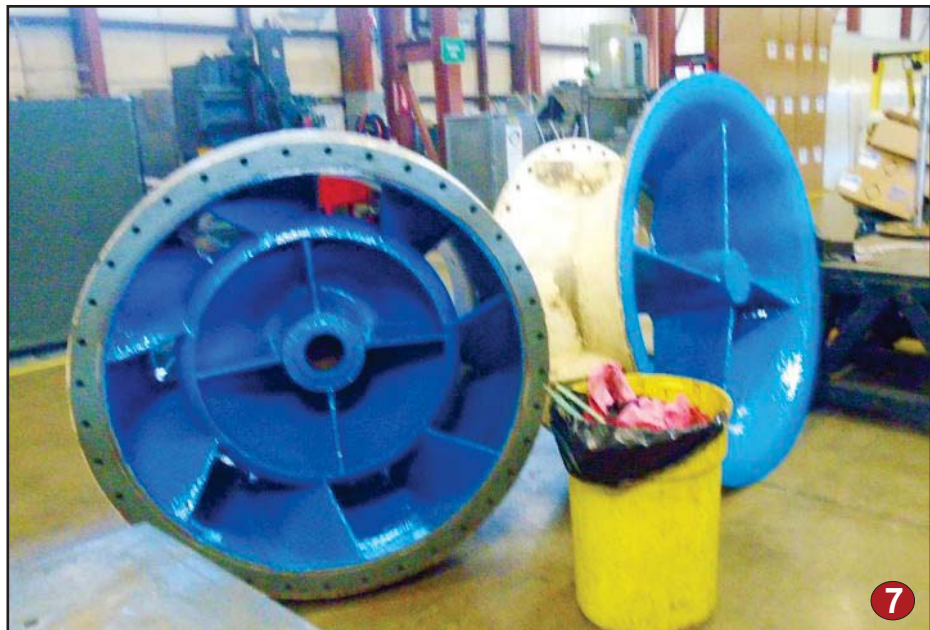
Problem: Debris such as sticks, trash and silt eroded this municipal storm water drain pump bowl's veins (pg.1). The debris also broke the impeller's veins (pg. 2).

Solution: A new 'skeleton' for the veins was constructed by welding metal bars and wire mesh. CeramAlloy CP+AC was used to rebuild the veins and CeramAlloy CL+AC protected all the internal pump surfaces.

Savings: A new pump has a 24 week lead time. The ENECON solution was completed in 1 week and provided over \$50,000 in savings.
