DuraWrap Repairs 24 Inch Force Main Pipe At Florida Wastewater Treatment Plant

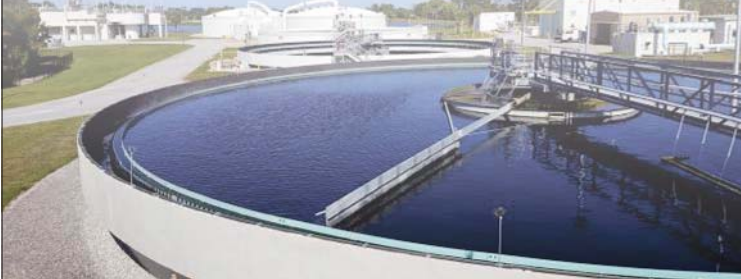
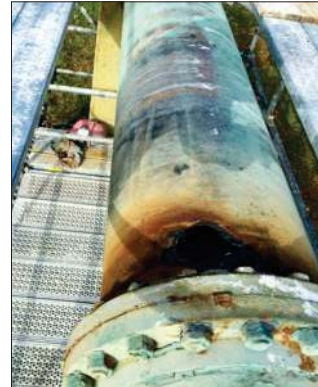
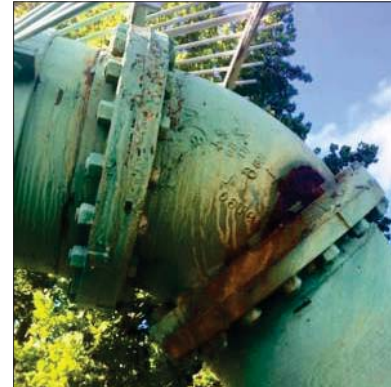
A major central Florida wastewater treatment plant had severe corrosion on a 24 inch force main pipe that could not be taken out of service. Replacing the pipe was not an option. It had to be repaired while it was still in service.

The local ENECON salesperson suggested repairs to the holed areas

with DurAlloy and wrapping the pipe with ENECON's DuraWrap carbon fiber pipe wrap system followed by a top layer of ENESEAL CR.

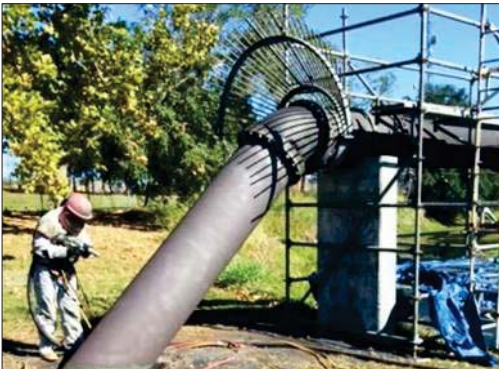
Grit blasting

The pipe was first grit blasted to remove old coatings, surface corrosion and provide the needed profile.

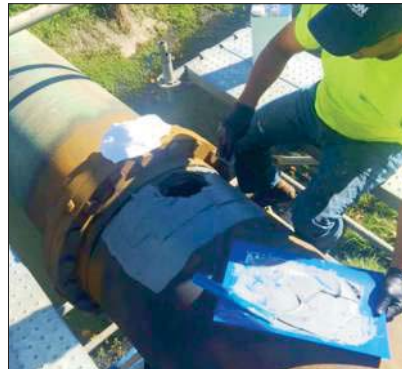
Applying DurAlloy

All visible holes were repaired with DurAlloy. The largest hole was repaired

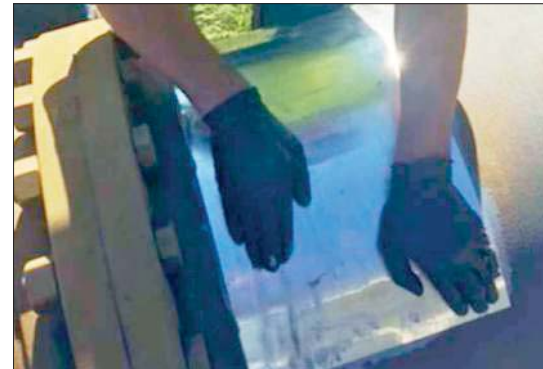
Bonding the stainless steel plate

by applying DurAlloy to the area around the hole then bonding a piece of stainless steel in place over it.

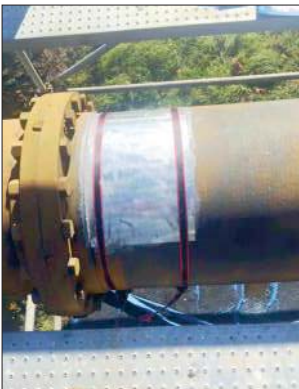
Tension straps

Tension straps were placed around the steel and pipe for 24 hours to ensure a proper fit for the repair.

The next day the straps were removed and a small amount of DurAlloy was used around

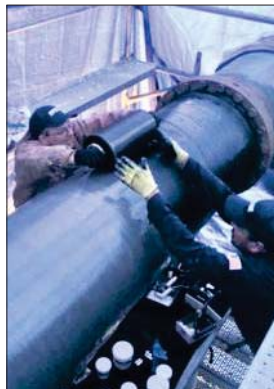
Carbon fiber pipe wrap

the edges of the repair. DuraWrap primer was applied to the pipe. Then 12 inch wide carbon fiber was wrapped around the pipe and wetted out at the same time.

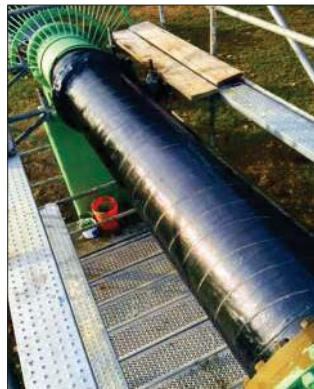
Finished repair

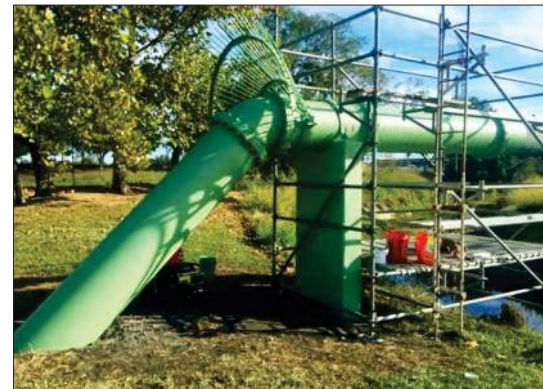
ENESEAL CR

A final top coat of ENESEAL CR green was then applied for corrosion resistance and aesthetics.
