CHEMCLAD XC "Cures" Shower Stall Problems at New Jersey Hospital

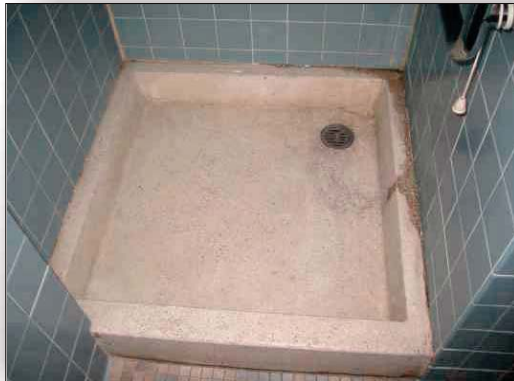
Worn, pitted basins were unsightly & impossible to clean.

After years of constant use, the basins had become worn and pitted and the original sealer finish was gone. The basins were nearly impossible to clean and unsightly as well. Patients were reluctant to use the showers. Since occupancy is as important to a hospital as to a hotel, each shower had to be completed in one day as rooms became available.

The solution was the application of CHEMCLAD XC, tinted to the color (blue) selected by the hospital staff to compliment the wall tile color.

After acid washing the basins to remove imbedded soil, soap residue and rust stains, the basins were dried using a fan.

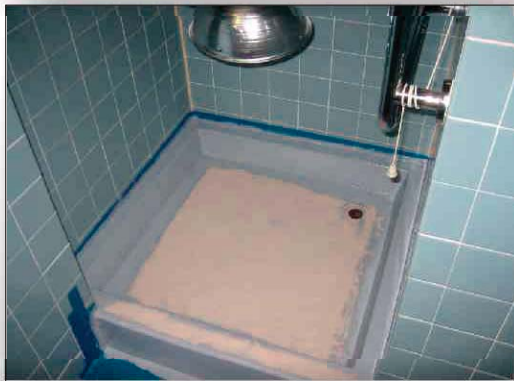
Heat lamps were used to accelerate the cure of the first layer of CHEMCLAD XC

A first layer of CHEMCLAD XC was applied by brush and roller. An anti-slip aggregate was broadcast into the uncured CHEMCLAD XC. This filled in pits in the concrete surface and improved the safety of the showers. After sweeping up the excess aggregate, a second layer of CHEMCLAD XC in the finished color was applied.

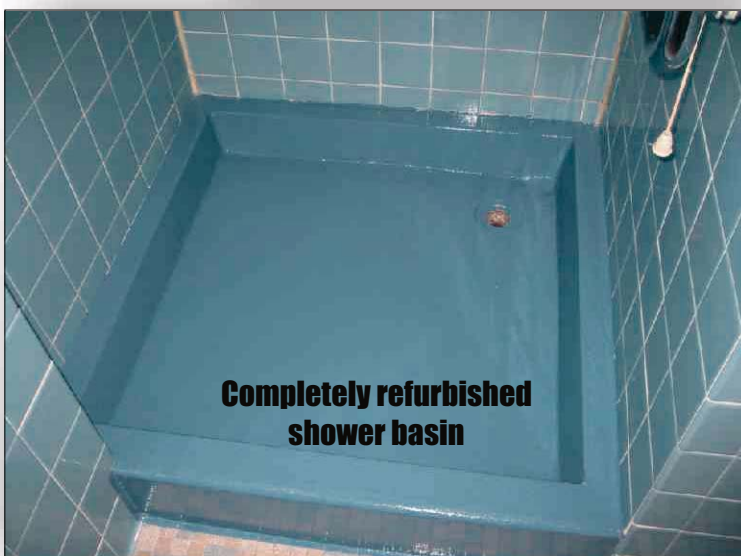
The finished basins have an easy-to-clean and safe "diving board" finish. Over 80 showers have received this treatment.
