Leaking Hospital Kitchen Grease Trap Is Repaired With DurAlloy & Protected With CHEMCLAD

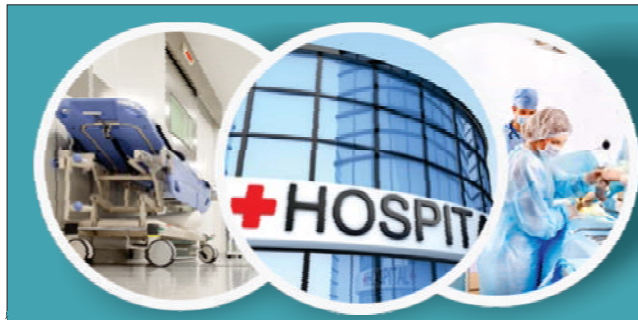
This particular grease trap (1) is a pit located underground at a Pennsylvania hospital kitchen. It was leaking into the ground, which was a concern for the hospital maintenance team. A full replacement of the grease trap would have been very expensive and caused major disruption to the hospital's busy kitchen for days.

The prescribed solution from the ENECON Field Engineering Specialist was much more economical for the hospital. After the grease was removed and the pit cleaned, sheet metal was used to build a new base for the trap (2). DurAlloy was then used to seal any seams or gaps between the sheet metal and the existing pit walls (3). Finally, two coats of CHEMCLAD SC were used to protect the inside of the trap from future corrosion (4).
