## Polish Water Treatment Plant Solves Concrete Waterproofing Problems with ENECRETE WP & WS

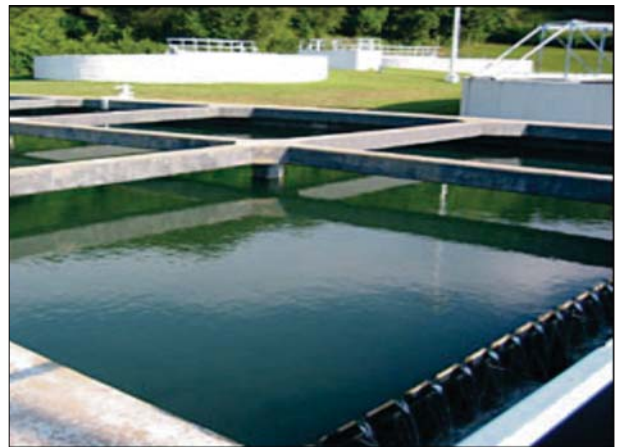
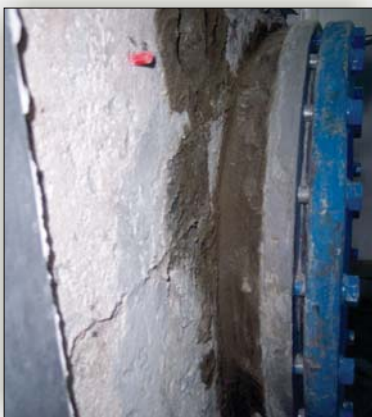
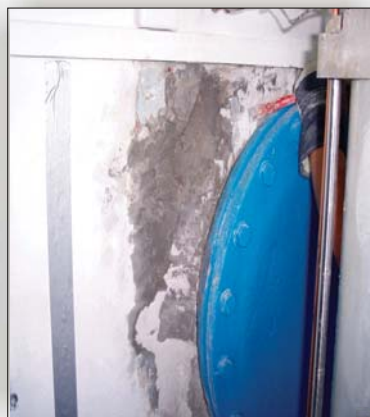
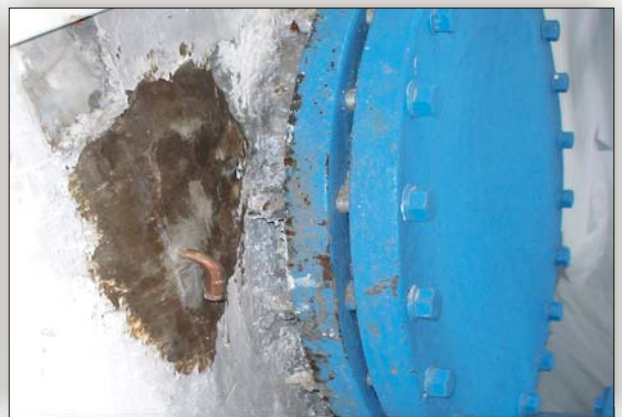
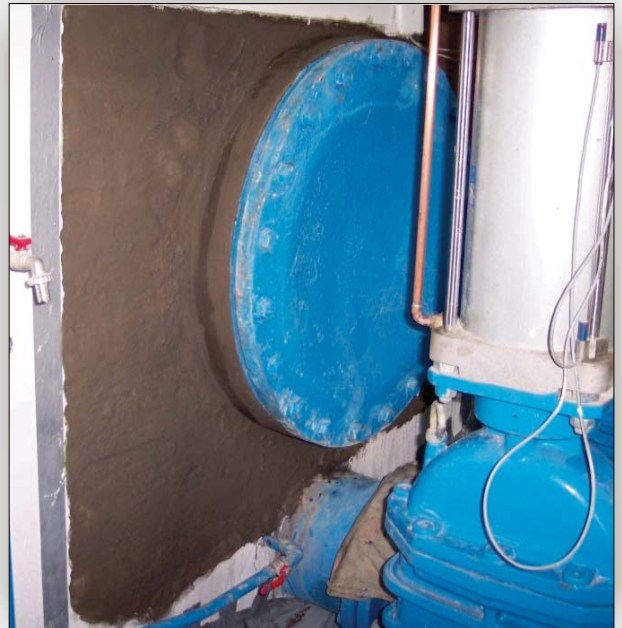
"These pictures are from a water treatment facility. There was a problem with a concrete tank used for water conditioning / purifying. This tank contains sand which helps to clean the water. After a number of years, the tank was no longer waterproof. There were many leaks, especially near the pipes that go through the tank. Our client tried to solve this

problem many times but nothing helped. We tried to help and we succeeded.

We thoroughly cleaned the surface of the wall and the pipe, dried it out and then applied SuperBond to the metal pipe. We then filled the space between the pipe and the wall (about 4 cm wide and 8 cm deep) with WP and then applied a trowelable layer of WS to smooth it out and make it look nice. All the leaks in the concrete wall were

sealed with WP and then followed by 2 coats of WS to seal the porous cement.

Everything looks nice and it really works. We are now looking at other repairs on this tank which is about 20 meters long x 20 meters wide x 10 meters high."
