ENECON® NEWS

EC-038

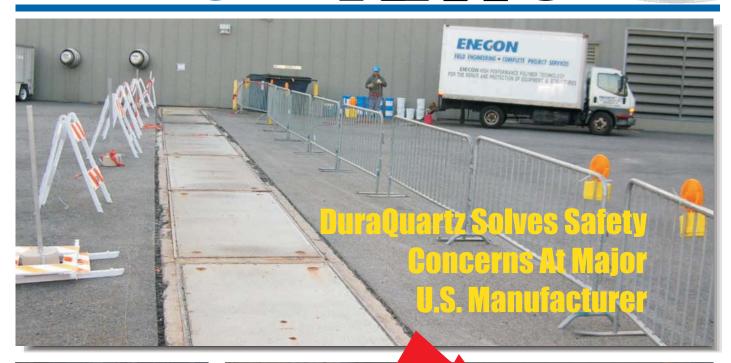
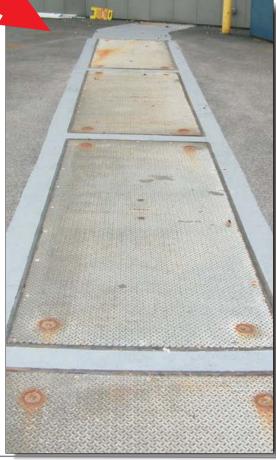
The access gates of this underground pipe chase had become a safety concern for the facility's engineers.

This high traffic area, subject to countless freeze/thaw cycles, had been repaired many times with conventional water-based cementious materials with little success. The local ENECON Engineering Specialist was contacted to find a cost effective, fast and safe solution.

It was suggested that all of the loose material in the damaged areas surrounding the access plates be removed and then cleaned. **ENECRETE DuraQuartz** was then used to build up and level out the damaged concrete surfaces.

By using the DuraQuartz system, the facility's engineers not only solved the 'safety problem', they were able to do it under budget and on time.
